Inspection Report

Property Address:

1233 Main St

DLM Home Inspection

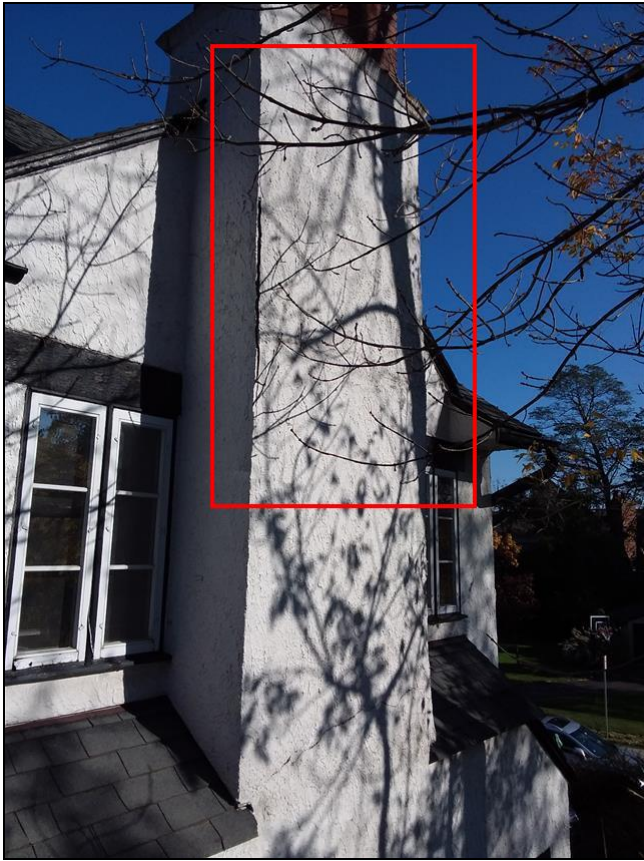
**1.0 (1)** The stucco siding is in overall good condition, cracking and deterioration were noted at the East masonry chimney that can allow water penetration and damage to the chimney. A qualified stucco contractor should evaluate further and repair as needed.

Deteriorated stucco at chimney

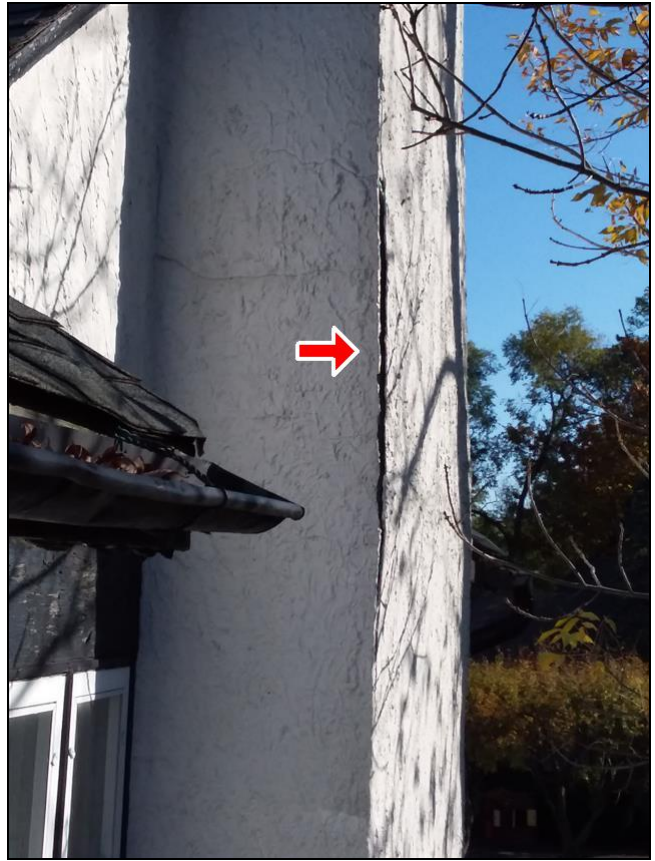
Cracked stucco at chimney

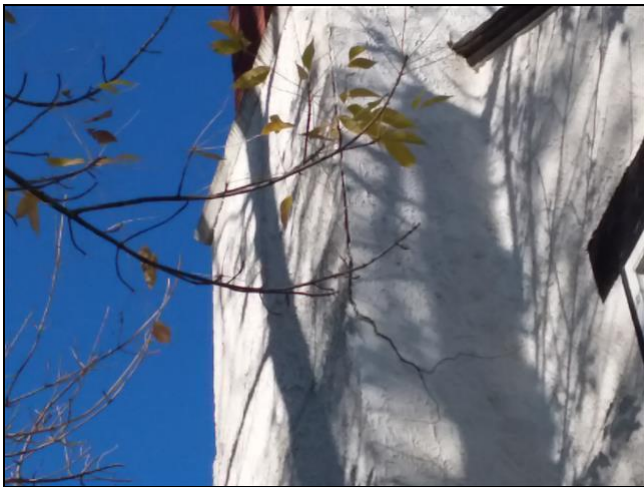
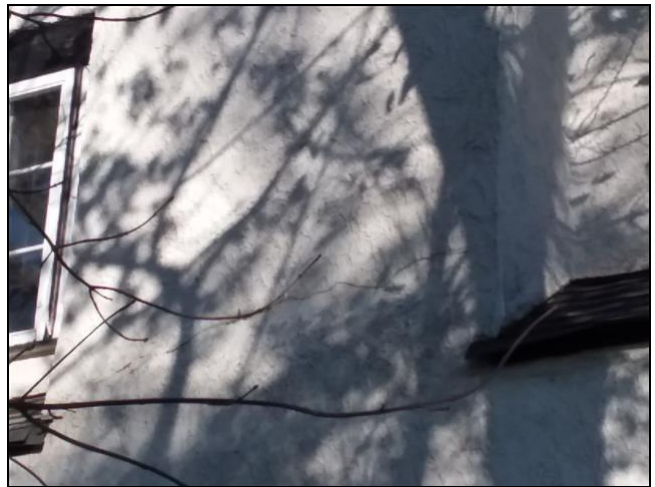
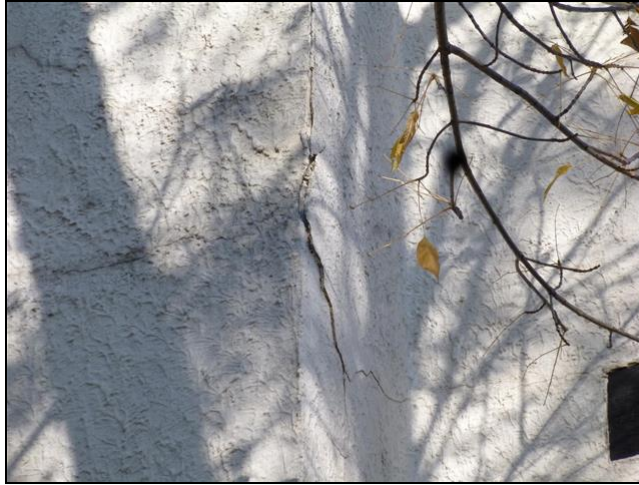
Cracked stucco

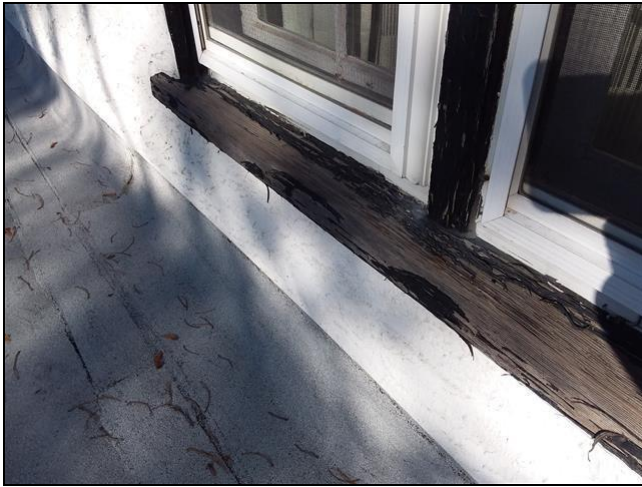
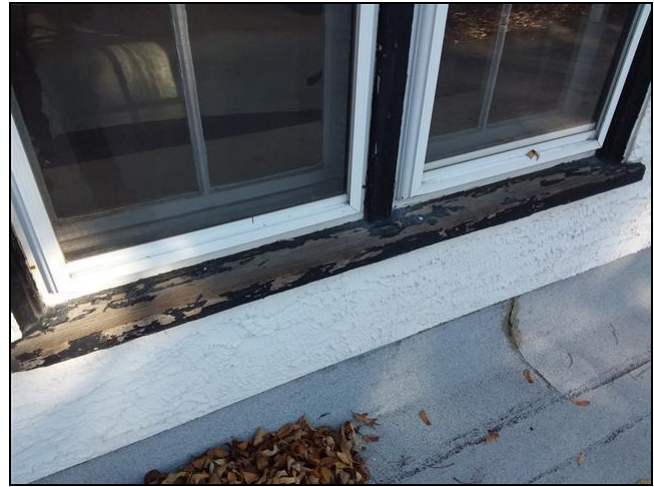
**1.0 (2)** The exterior trim paint is aged and in need of servicing, preparation and repainting. The Client should budget for near future preparation and repainting of exterior surfaces.

Deteriorated trim paint

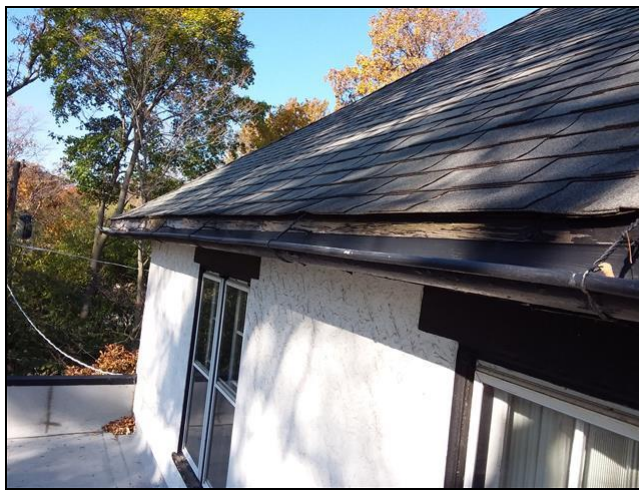
Exposed wood at fascia

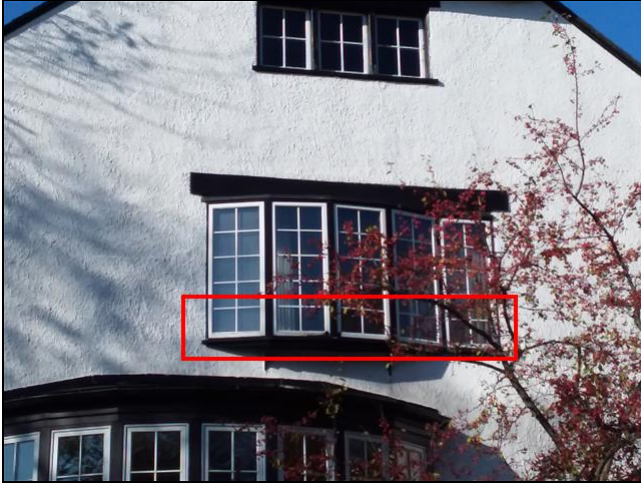
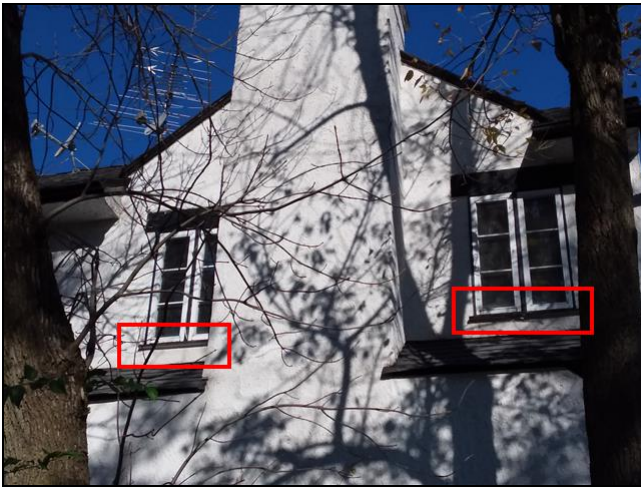
1.3 The wood windows are water damaged and rotted at the South and East sides of the home. Repair is needed to prevent water entry and damage to the interior. A qualified contractor should evaluate further and repair as needed.

Damaged windows

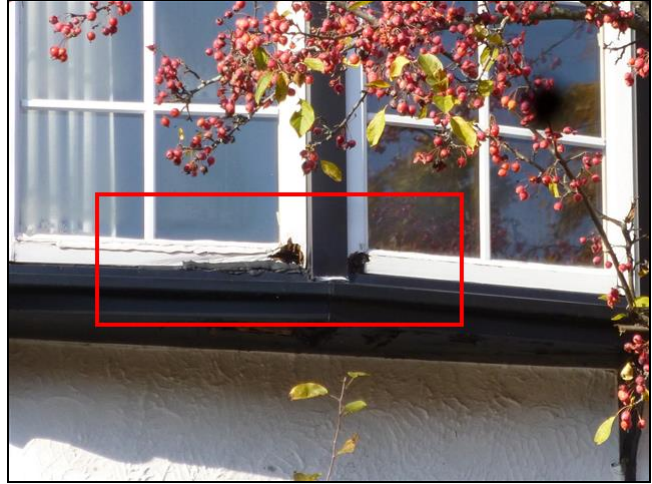
Master bedroom windows

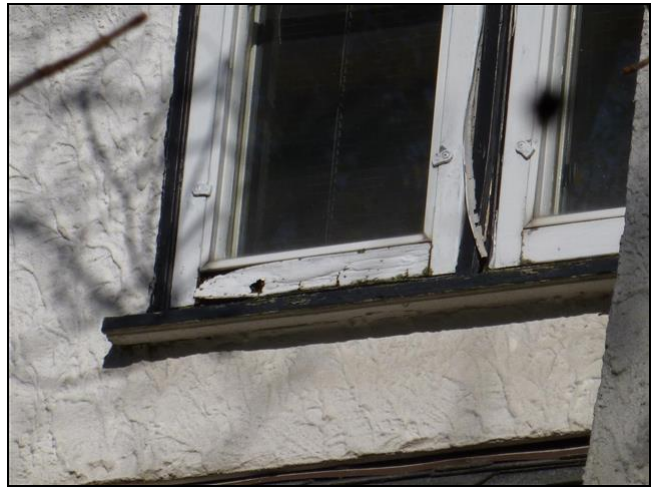
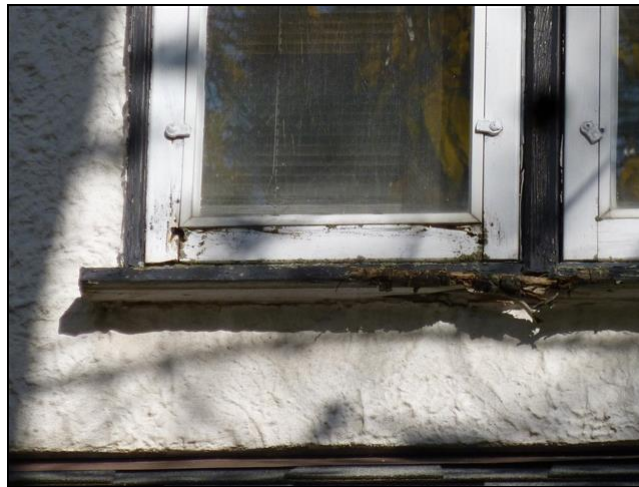
Master bath window

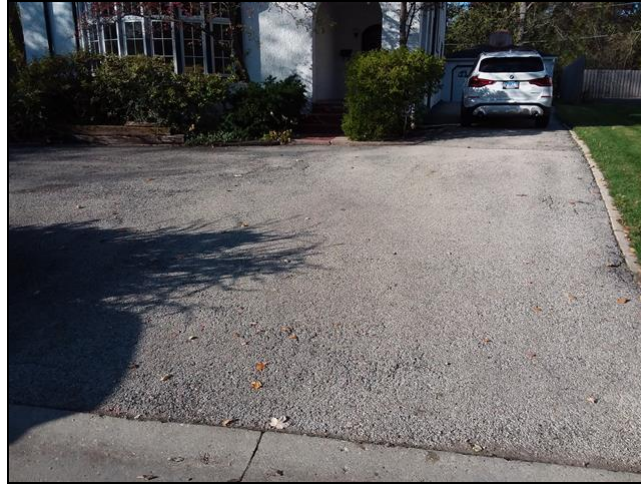
1.5 (1) The asphalt paving at the driveway is cracked and in overall poor condition. Seal coating and crack-filling and/or patching should be performed to prevent water penetration and freeze/thaw damage. A qualified paving or asphalt maintenance contractor should repair as needed.

Worn, deteriorated asphalt driveway

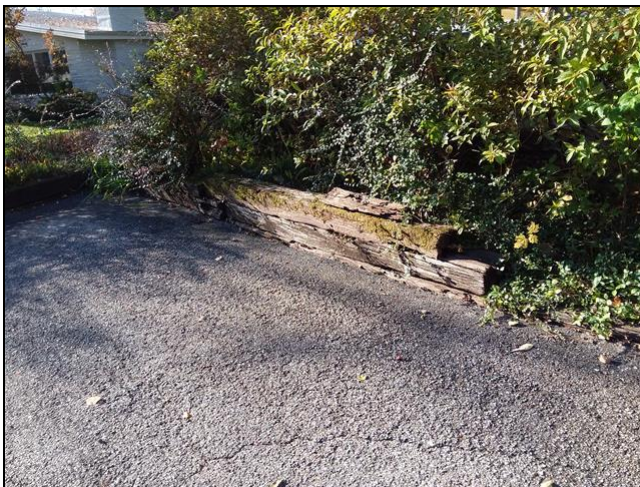
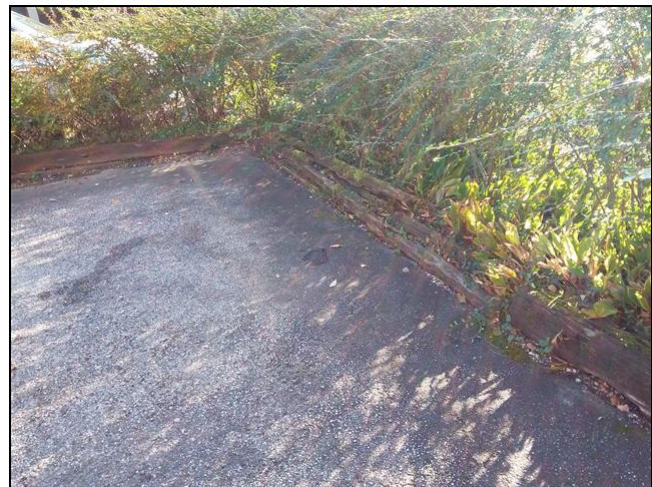
1.5 (2) The wood timber wall at the front of the home is leaning and erosion signs are present. This problem will continue to become worse and needs correcting. Old leaning walls can slowly deteriorate remaining upright for years and sometimes erosion or settlement can cause the wall to fail faster. A qualified landscape contractor should evaluate further and repair or correct as needed.

Failing retaining wall

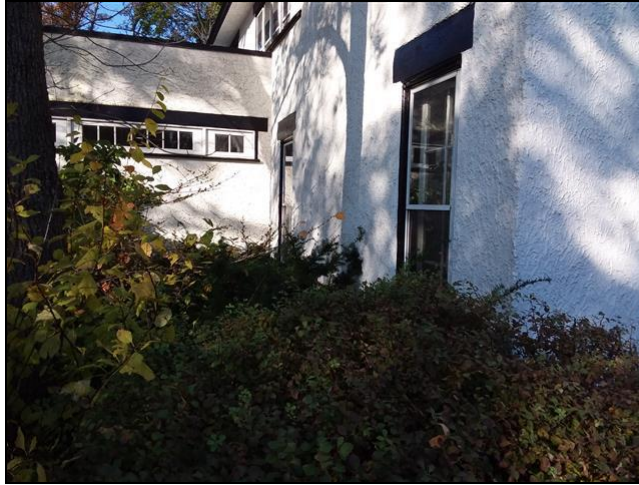
1.5 (3) The plants at the exterior of the home of the house have become overgrown and are in full contact with the stucco exterior finishes. These plants should be trimmed back to a minimum 12 inch clearance to provide airflow and reduce moisture being trapped between the plants and building surfaces leading to premature failure of these components.

Trim overgrown bushes

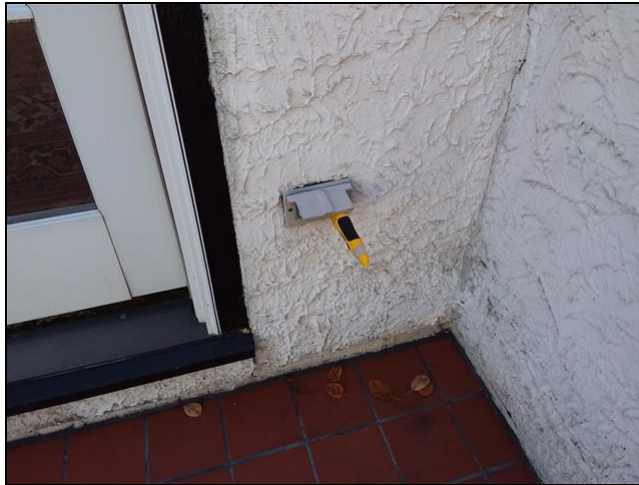
**1.7** The GFCI (Ground Fault Circuit Interrupter) outlet at the rear exterior wont trip when tested. This is a safety defect that can cause electric shock. A qualified electrical contractor should replace the defective outlet.

Outlet will not trip when tested

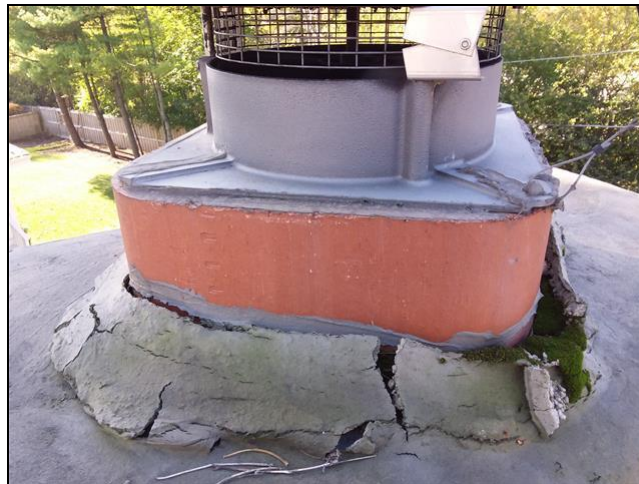
2.2 The sloped mortar wash at the SW chimney is cracked and deteriorated. Repair is needed to prevent water entry and damage to the interior masonry chimney. A qualified masonry contractor should repair as needed.

Cracked, deteriorated mortar wash

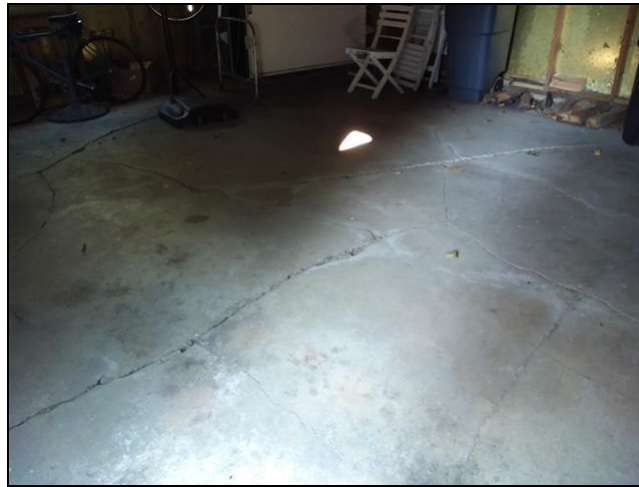
3.3 The concrete garage floor is cracked. While these cracks do not appear significant enough to cause slab movement, the floor should be monitored for additional cracking or deflection. If additional cracking or displacement does occur, a qualified concrete contractor should be consulted for repair or replacement options.

Cracked garage floor

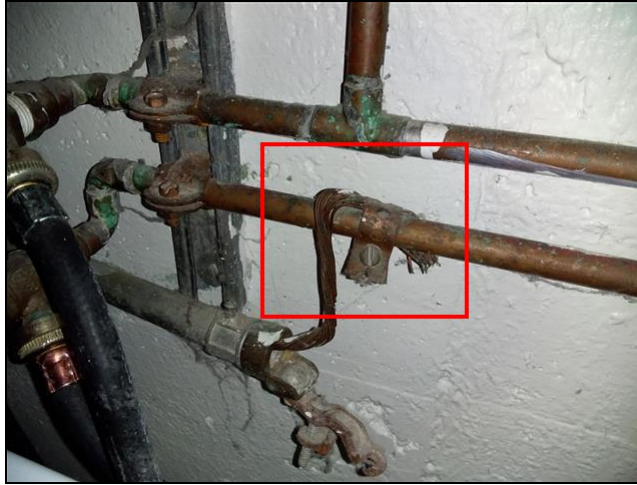
**5.1** (1) The grounding electrode conductor at the water pipe connection is not properly secured to the pipe. The stranded copper grounding conductor has been squeezed between a metal strap and the pipe. This is not allowed and is unsafe as it makes the clamp prone to loosening and can reduce the safety and effectiveness of the bonding and grounding system. The existing clamp should be replaced with one that can properly secure the grounding electrode conductor into a screw terminal. Further evaluation and repair by a licensed electrical contractor is recommended.

Improperly installed ground bonding connection

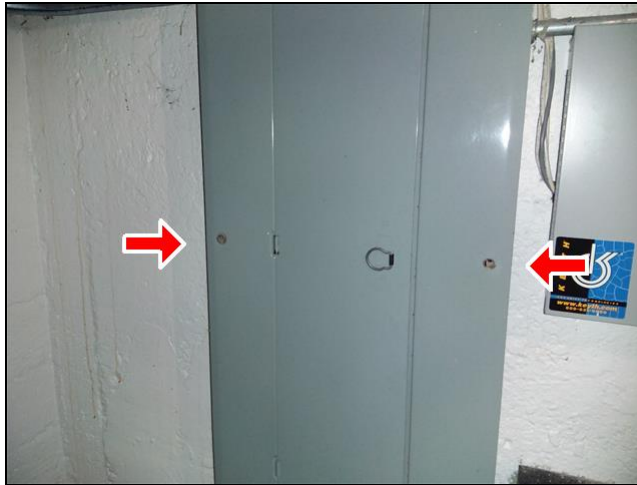
**5.1 (2)** The missing electrical panel cover screws should be provided and installed. A qualified electrical contractor should install as needed.

Replace missing panel cover screws

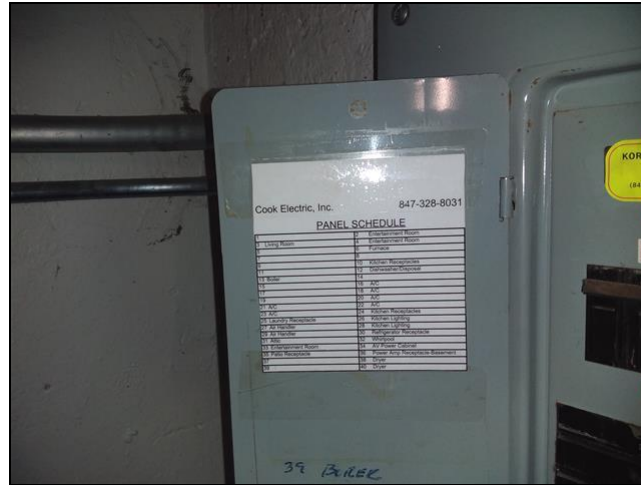
**5.1 (3)** A complete and accurate electrical circuit directory should be provided to the buyer before closing in order to allow for safe and efficient electrical circuit interruption when required for maintenance, repairs, or in emergencies. Each circuit should be clearly and specifically identified as to its purpose. No two circuits should be labeled the same. No circuit should be identified in a way that may be subject to change with occupancy. For example, no breaker should be labeled “Ben’s bedroom.”

Incomplete circuit directory at panel

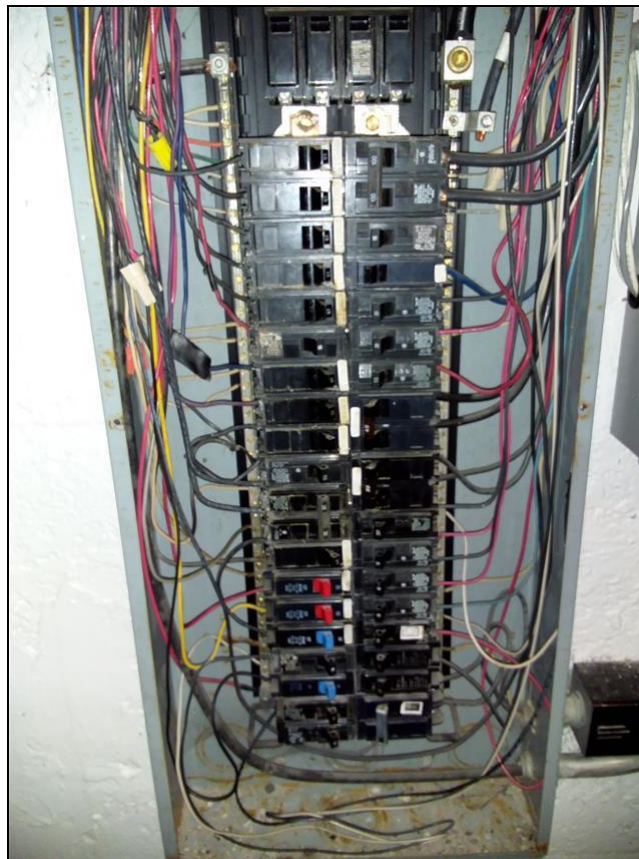
**5.1 (4)** Multiple circuit breakers in the main panel are of a different brand than panel manufacturer. Most manufacturers require that only their breakers be used in order for the panel to meet minimum safety requirements. Even though these circuit breakers are all "UL approved," they are typically not approved to be used in panels of different manufacturers unless so indicated on the panel label. A qualified electrical contractor should evaluate and repair the panel as needed for safe electrical power distribution.

Circuit breakers from 7 different manufacturers are present

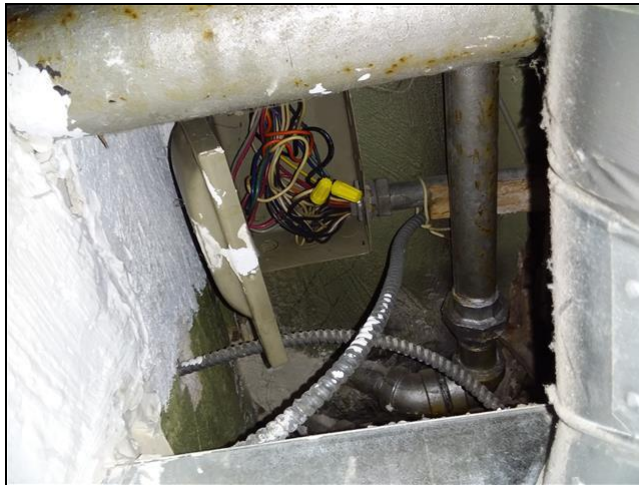
**5.2 (1)** One junction box needs to be covered in the basement. Repairs are needed to prevent contact with energized wiring. A qualified licensed electrician should correct as needed.

Open junction box

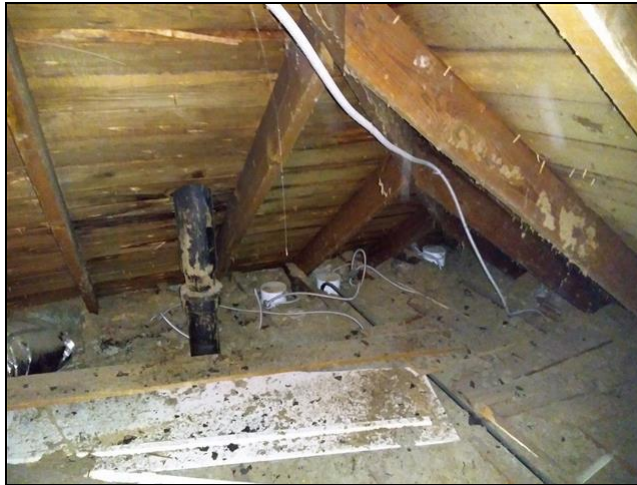
Amateur attic wiring

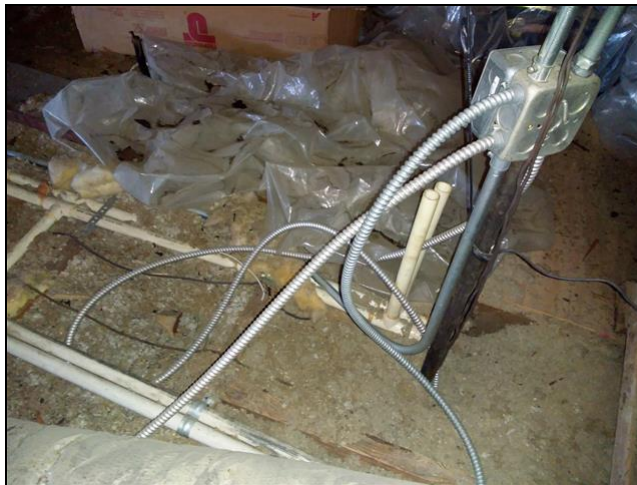
5.2 (3) The use of flexible metallic sheathed cable (aka BX cable) indicates that the installation may have been performed by unlicensed and/or unqualified personnel. The BX installation should be reviewed by a qualified electrician for safety. Removal and replacement with wire in rigid conduit is recommended to conform with local building practices.

BX wiring in attic

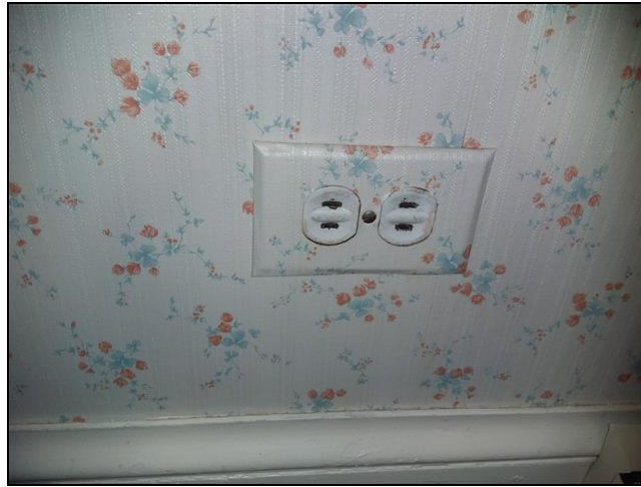
**5.3 (3)** Some of the outlets in the home are 2 pronged outlets that lack a connection for the ground conductor found on most modern electrically powered equipment. The 2 pronged receptacles in the home should be replaced with 3 pronged receptacles for increased safety and convenience. A qualified electrical contractor should replace where needed.

Replace 2 pronged outlets

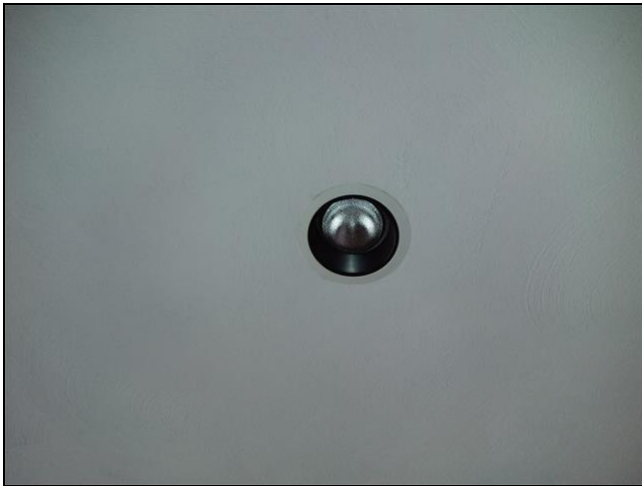
**5.3 (5)** Any extinguished or missing bulbs should be replaced and operable to indicate proper fixture function prior to closing. Non-working or defective light fixtures should be replaced by a qualified electrical contractor.

Living room ceiling light out

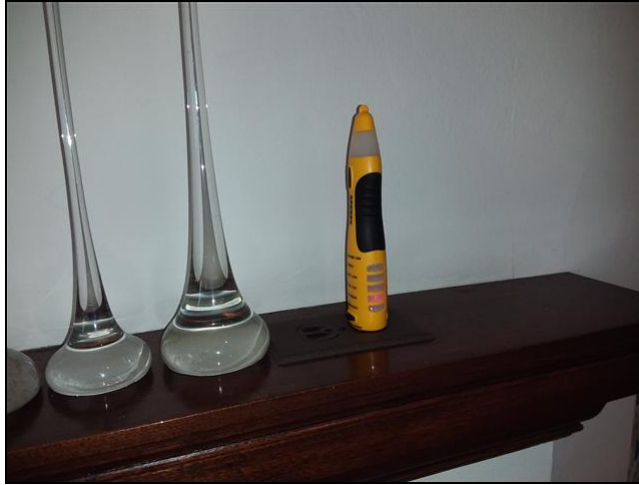
**5.3 (6)** One outlet is not grounded in the living room. This is a safety defect that can cause electric shock. A qualified licensed electrician should repair as needed.

Ungrounded outlet

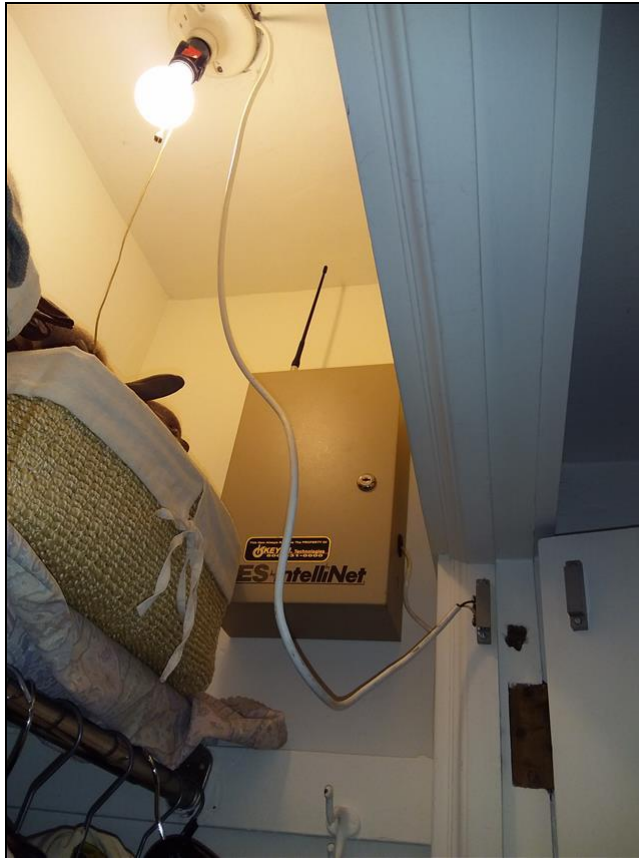
**5.3 (7)** The exposed power cord wiring at the entry closet light is exposed and improperly connected to the electrical junction box. Repair is needed to prevent risk of electric shock or fire. A qualified electrical contractor should repair as needed.

Improperly installed electrical wiring

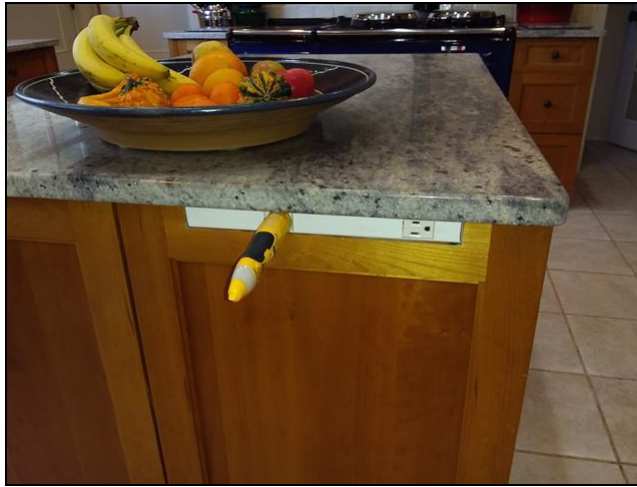
**5.3 (8)** The outlets are not working at the kitchen island. Further inspection is needed by a qualified licensed electrical contractor. A qualified licensed electrician should perform repairs that involve wiring.

No power at outlets

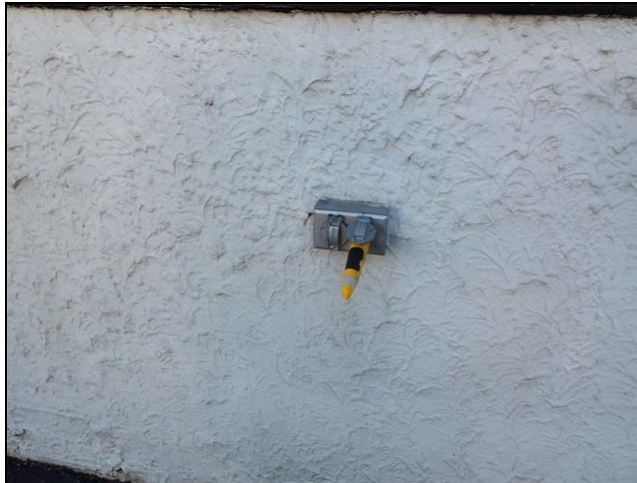
**5.4 (1)** It is recommended that all electrical receptacles at kitchen counters, in bathrooms, garages and all exterior locations that are not already GFCI protected be upgraded to GFCI protected outlets by a licensed and competent electrician in order to reduce the risk of electrical shock and injury.

Non-GFCI exterior outlet

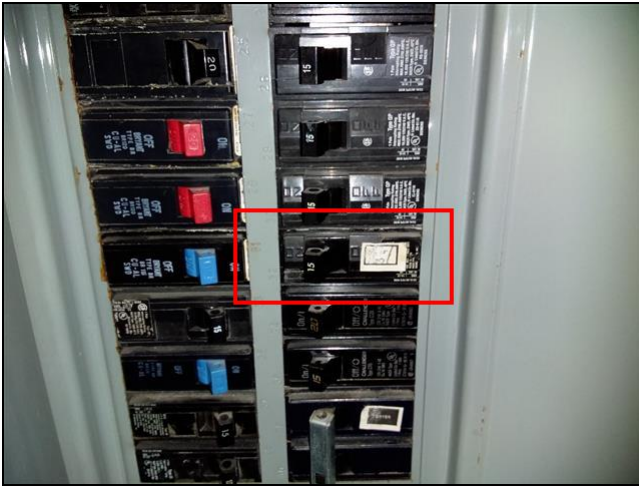
**5.4 (2)** There is no GFCI circuit protection for the hydro-massage tub. This is a serious safety defect that can cause severe injury or death in the event of an electrical defect at the tub motor or wiring. A qualified electrical contractor should correct as needed for safety.

Non-GFCI breaker for tub motor

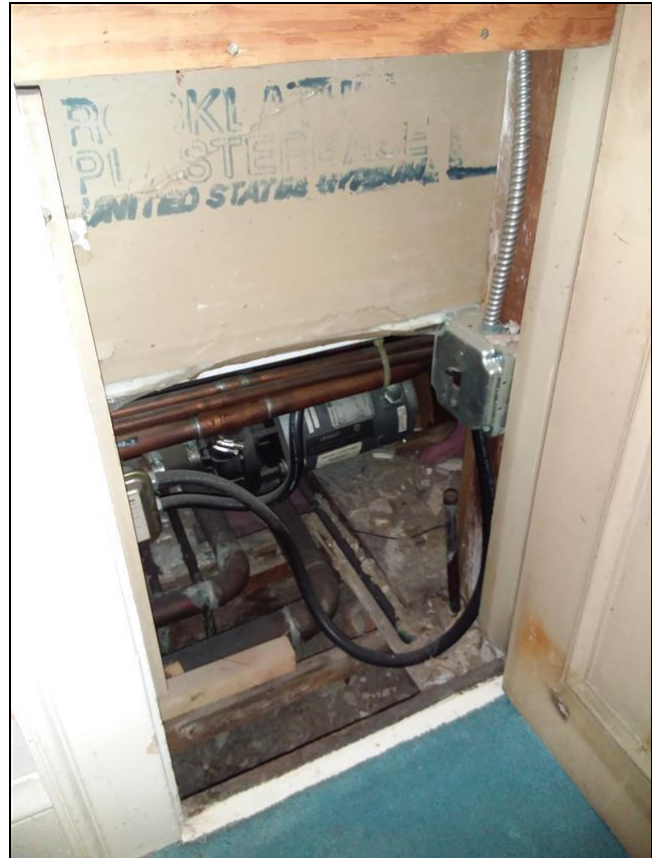
No GFCI protection at tub motor

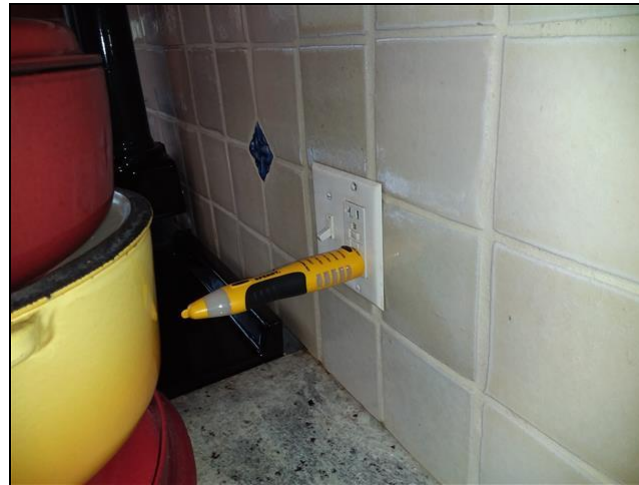
⚠️ + 5.4 (3) One GFCI (Ground Fault Circuit Interrupter) outlet at the kitchen did not work or there is no power to outlet. Further inspection is needed by a qualified licensed electrical contractor. A qualified licensed electrician should perform repairs that involve wiring.

No power at outlet

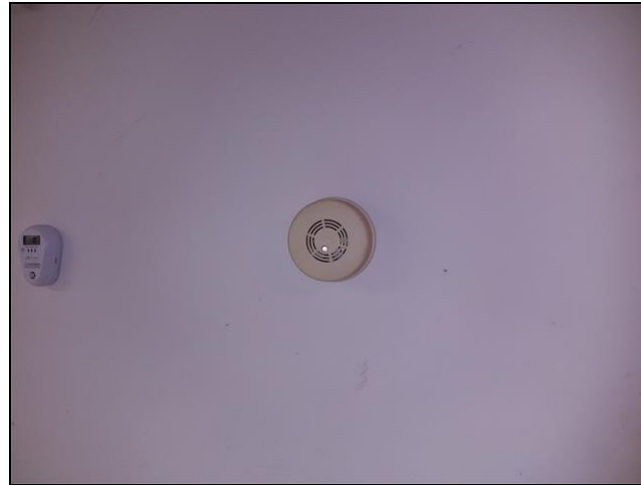
🏠 + 5.5 (1) Some of the safety detectors in the home appeared to be at or beyond the end of their service lives, typically estimated to be 10 years for smoke detectors and 5 years for carbon monoxide detectors. It is recommended that the smoke detector and carbon monoxide detector systems be upgraded to reflect current life safety practices which include; smoke detectors on each level of living space and in each sleeping room, hard-wired 120 V smoke detectors that are interconnected in order to alarm simultaneously when any individual smoke detector

responds, and carbon monoxide detectors on every level of living space and within 15 feet of a sleeping room. The installation of these critical life safety devices by a licensed and competent electrician is recommended.

Old, yellowed basement smoke detector

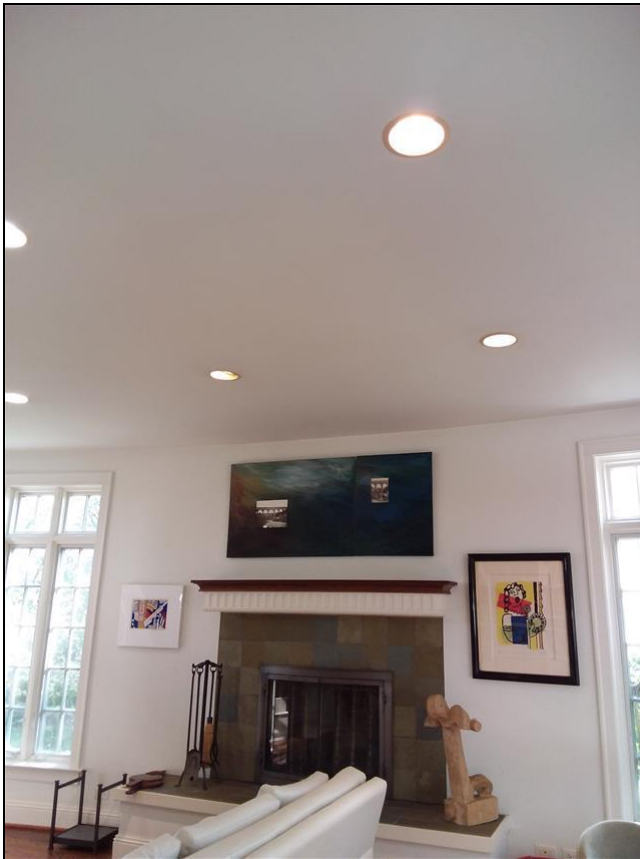
5.5 (2) There are no smoke or carbon monoxide detectors installed in the room containing the fireplace. The installation of these life-safety devices is required to immediately warn of any firebox or exhaust flue defects or blockages. A qualified electrical contractor should install as needed for safety.

No smoke detector in family room

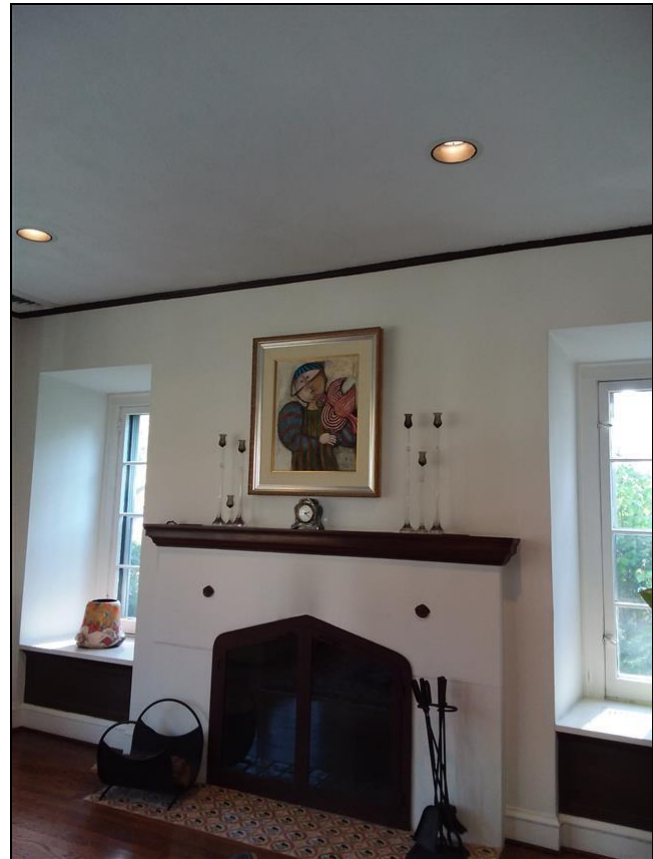
No smoke detector in living room

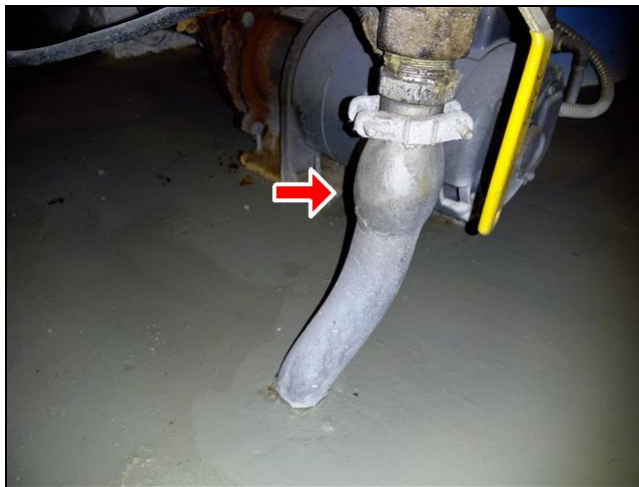
**6.1** The main water service to this home consists of lead pipe. The EPA has determined that no amount of exposure to lead is safe, periodic testing of the water to this home is recommended. The Client should consult additional information available at the EPA website regarding lead in drinking water.

Lead water service piping

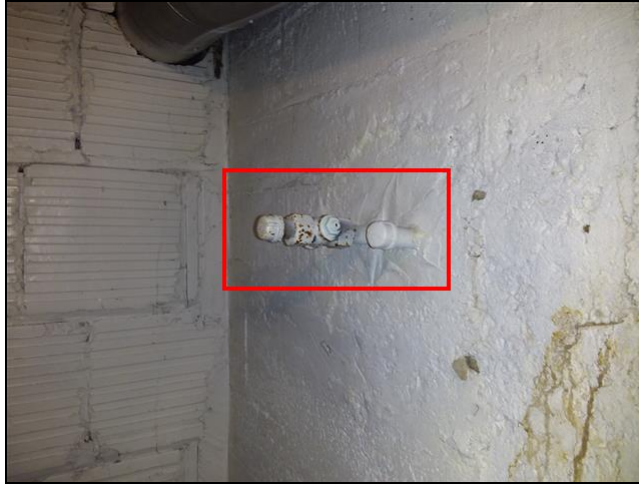
**6.4** The steel pipes penetrating the basement foundation wall may indicate the presence of an underground oil tank. These can cause an environmental hazard if they have not been emptied and certified as safe by an EPA-certified tank disposal company. Small amounts of leaking oil can contaminate large areas if not corrected. A qualified tank remediation contractor should evaluate further to determine if a tank exists and to ensure no hazards are present in the soils around the home.

Pipes penetrating foundation wall

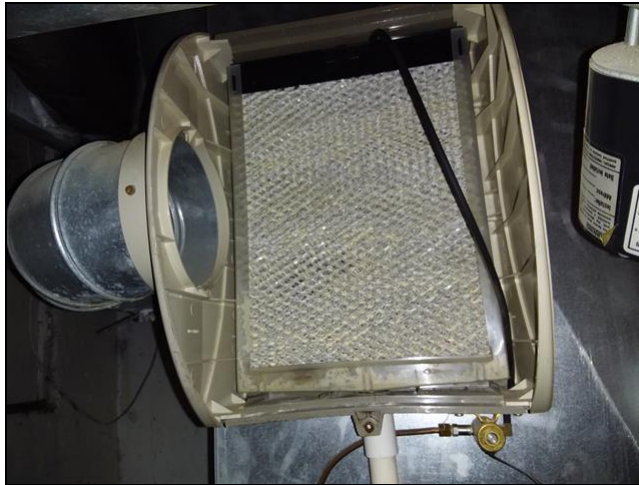
**7.3 (1)** The furnace-mounted humidifier should be cleaned and serviced each year at the start of heating season in order to optimize its operating efficiency and to also reduce any negative effects on indoor air quality. Replacement filters are available at most hardware stores and home centers.

Humidifier filter

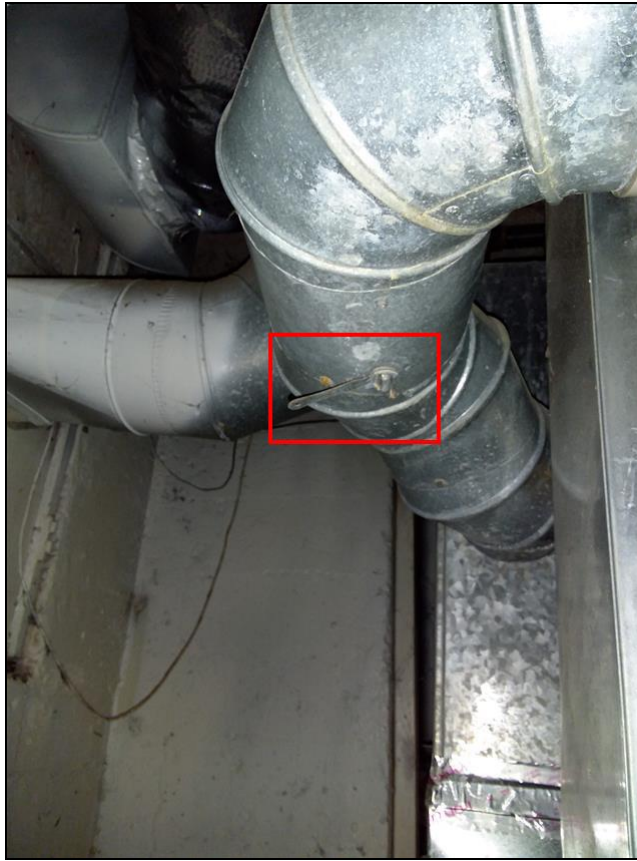
**7.3 (2)** The humidifier uses a duct damper for supply air in the winter and to shut off air-flow in the summer. A duct damper is essential on bypass style humidifier such as this in order to maximize energy efficiency and indoor air comfort. The damper should be adjusted at the change of seasons.

Duct damper control

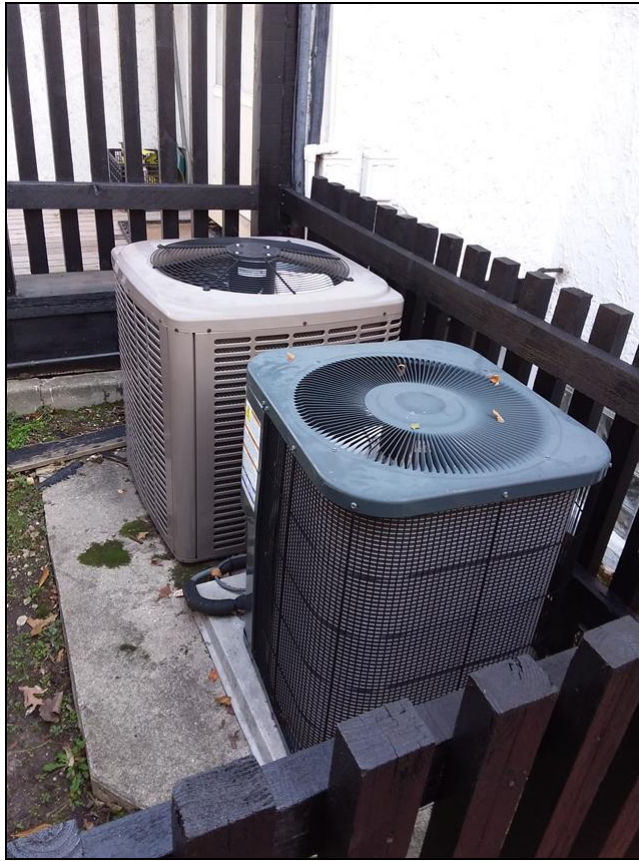
**7.6** Due to the low outdoor air temperature, the cooling system could not be tested without risk of damage to the equipment. Temperatures below 60 degrees can prevent the refrigerant from vaporizing completely which can damage the compressor. A home warranty or an escrow hold-back should be considered in order to protect the purchaser in the event that the air-conditioning system is defective or inoperative. Further evaluation of the air-conditioning system by a licensed and competent HVAC contractor is recommended when weather permits.

AC condensers

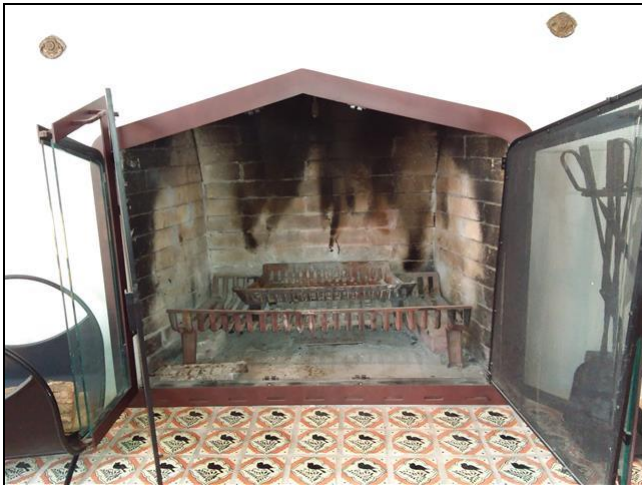
Living room fireplace

7.8 The National Fire Protection Agency recommends that wood-burning fireplaces be thoroughly evaluated when a home changes ownership. Evaluation of the fireplace in the home by a qualified specialty contractor, preferably one who is a member of the Chimney Safety Institute of America, is recommended.

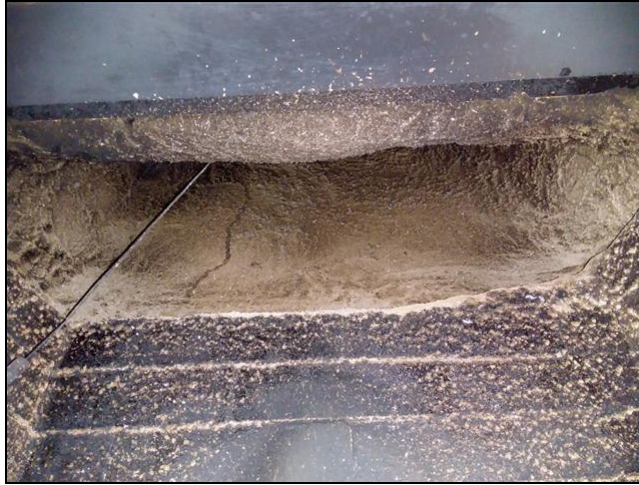
Dirty family room fireplace flue

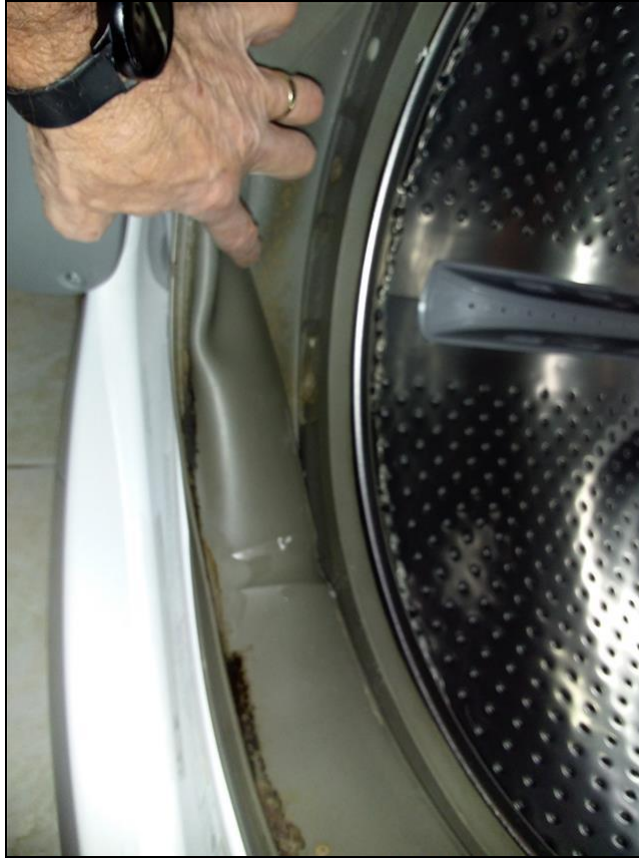
**9.7 (1)** The washer door seals have a moderate amount of fungal growth on the rubber door seal components. Front load washer doors should be kept open when not in use to allow air flow at door seals and to prevent ideal conditions for this type of fungal growth. The door seals should be cleaned with an EPA approved mold control product with residual mold inhibiting properties (Concrobium Brand) which can be found at major home improvement stores. Some badly stained door seals cannot be cleaned and will need replacement. A qualified appliance technician should replace the door seals if required.

Mold growth at washer door seal

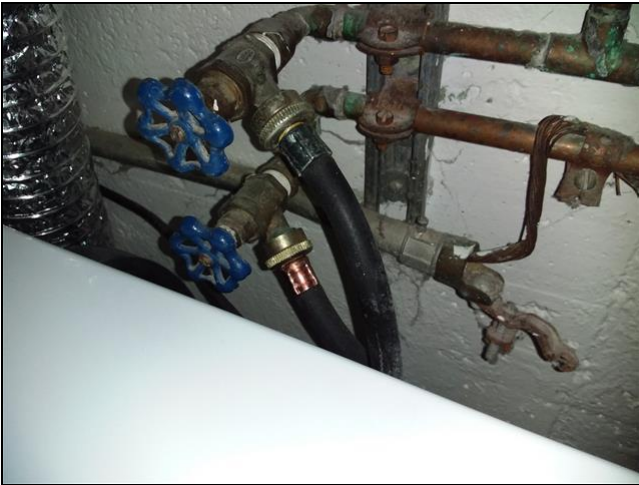
9.7 (2) It is recommended that the existing rubber water supply hoses at the clothes washer be replaced with braided stainless steel hoses for increased insurance against leaks and water damage.

Rubber washer hoses

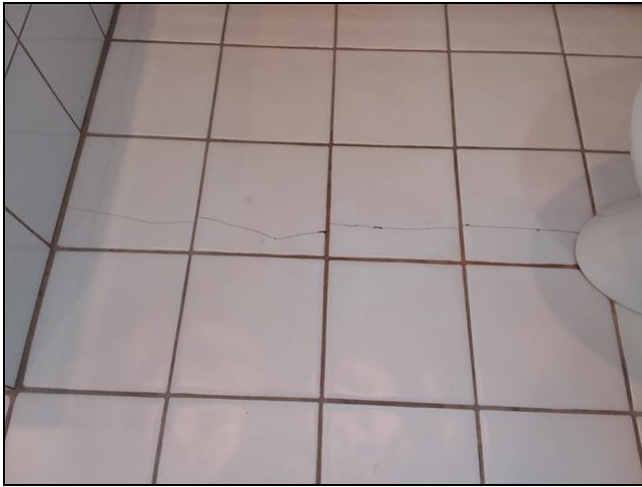
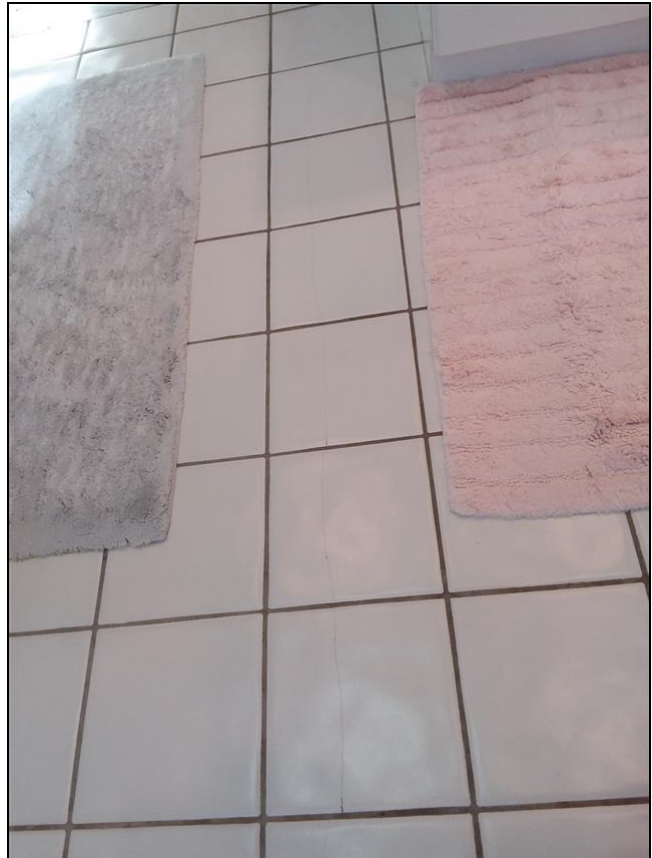
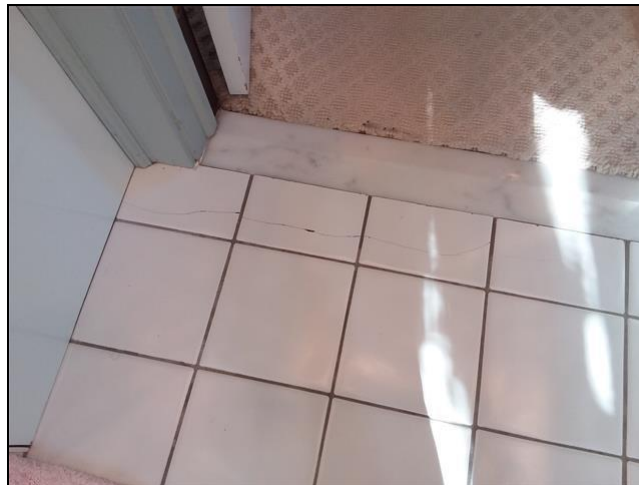
**10.1** Several tiles are cracked or damaged at the master bath. While this damage is cosmetic, the repair cost should be considered due to the probability the tiles cannot be matched and the entire floor will need to be replaced. Repair by a qualified flooring contractor is recommended.

Cracked floor tiles

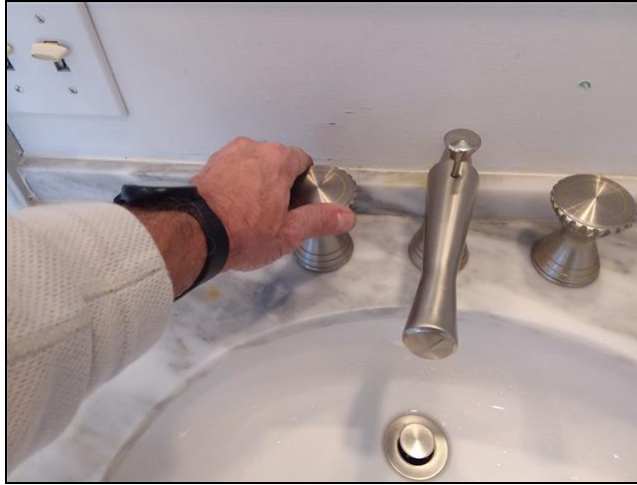
🔧 10.2 (1) The hot water control is loose and difficult to operate at the right master bath vanity sink. A qualified plumbing contractor should evaluate further and repair as needed.

Loose control sticks

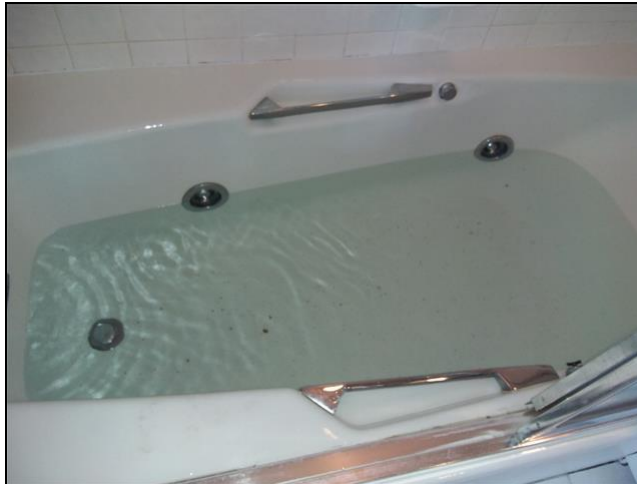
10.2 (2) Foreign material was noted during the operation of the hydromassage bathtub. This is common when the tubs are rarely used. It is recommended that the tub be filled with lukewarm water to a level at least 2 inches above the water jets; a cup of low-sudsing dishwasher detergent and several pints of hydrogen peroxide be added to the water; the hydromassage function of the tub should then be operated; the tub should be drained, refilled, operated again to rinse the interior piping, and drained. This procedure should be followed regularly to clean the interior piping of the hydromassage bathtub.

Debris in tub jets
