Inspection Report

Property Address:

1233 Main St

DLM Home Inspection

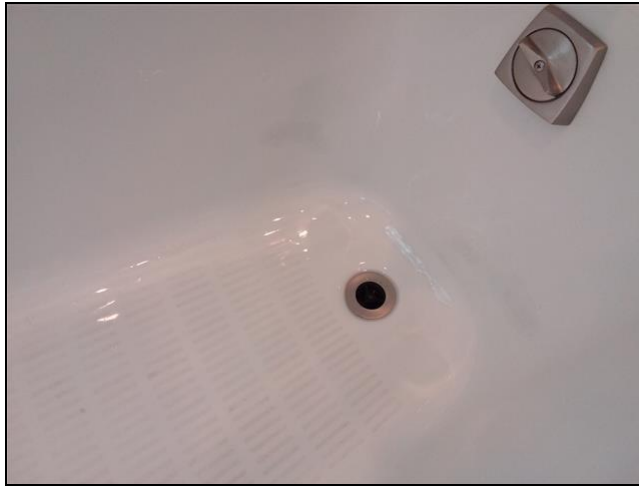
10.3 (1) The tub drain is damaged or missing and no longer operates at the master bath. Repair is needed to hold water in the tub. A qualified licensed plumber should repair or correct as needed.

Missing tub drain stopper

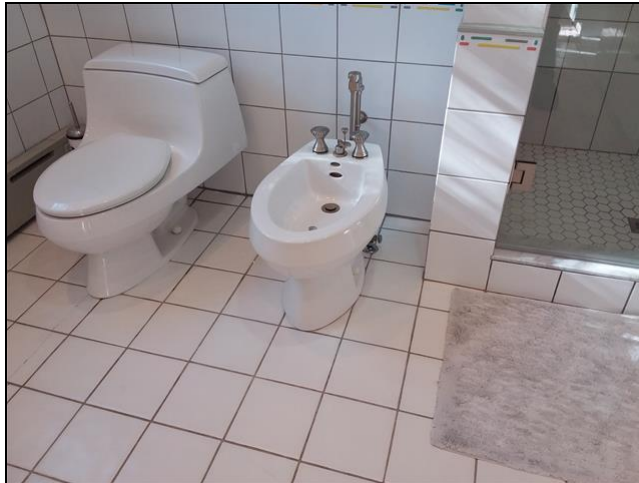
**10.3** (2) The master bath bidet is loose at the floor which can result in deformation of the wax ring seal and leaking at the toilet base. Repair is needed to prevent odors or water damage to adjacent finishes. A qualified plumbing contractor should evaluate further and repair as needed.

Bidet loose on floor

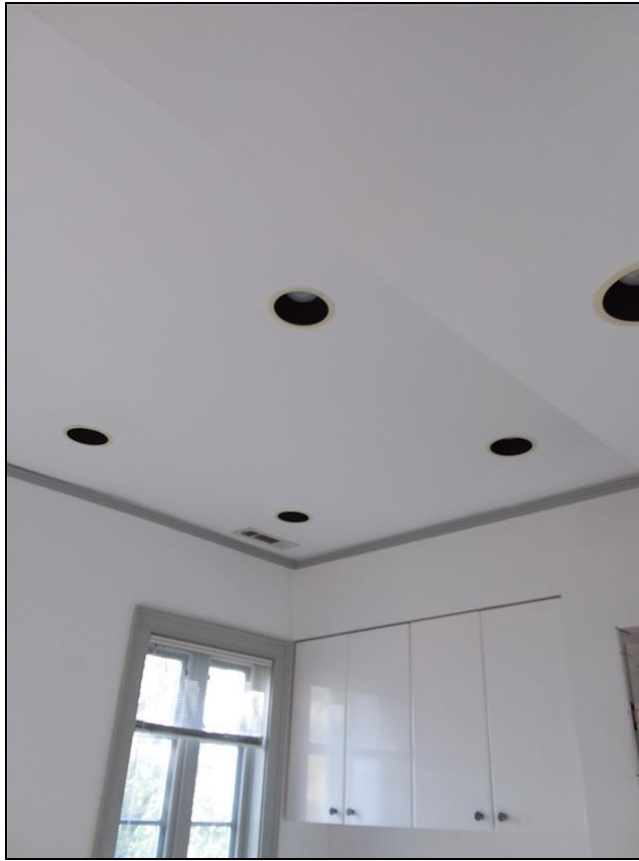
**10.4** The installation of a ducted bathroom exhaust fan is recommended in each bathroom in order to provide for the safe and effective removal of moisture and odors. While local building practices may allow the use of a bathroom window for ventilation, this method is ineffective, uncomfortable in the winter, and wastes energy. High quality, quiet, exhaust fans (preferably controlled with a timer switch) should be installed by a qualified contractor.

Add exhaust fan at each bath as needed

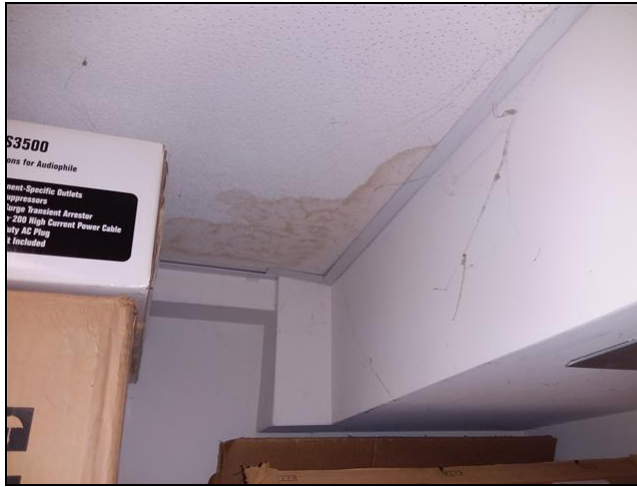
**11.0 (1)** The ceiling tile on the ceiling shows moisture stains indicating water intrusion did or still may be occurring at the basement. The moisture meter was used and it did not indicate an active leak. A qualified contractor or handyman should repair or replace as needed.

Water stains at ceiling tile

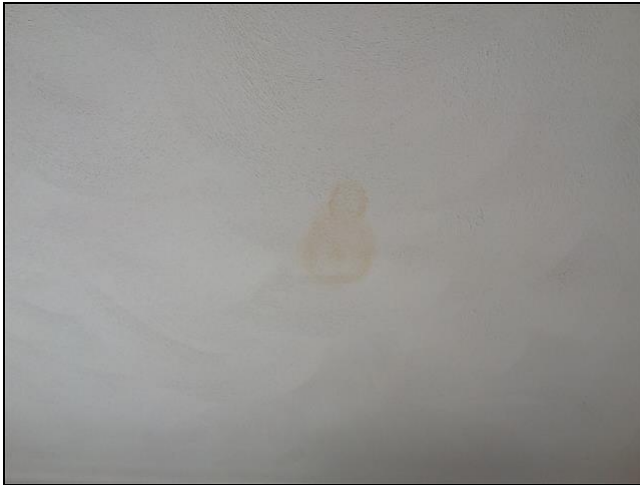
11.0 (2) The drywall on the ceiling shows moisture stains indicating water intrusion did or still may be occurring at the North and South bedrooms. Thermal imaging equipment was used and did not indicate an active leak. A qualified painting contractor should repair as needed.

Water stain at ceiling

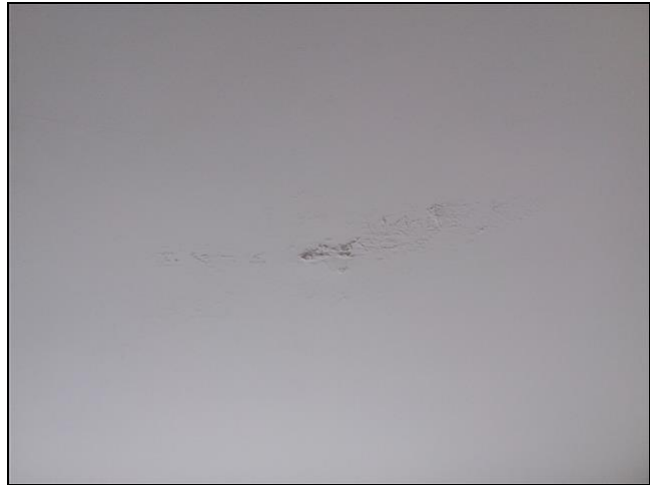
Moisture damage at ceiling

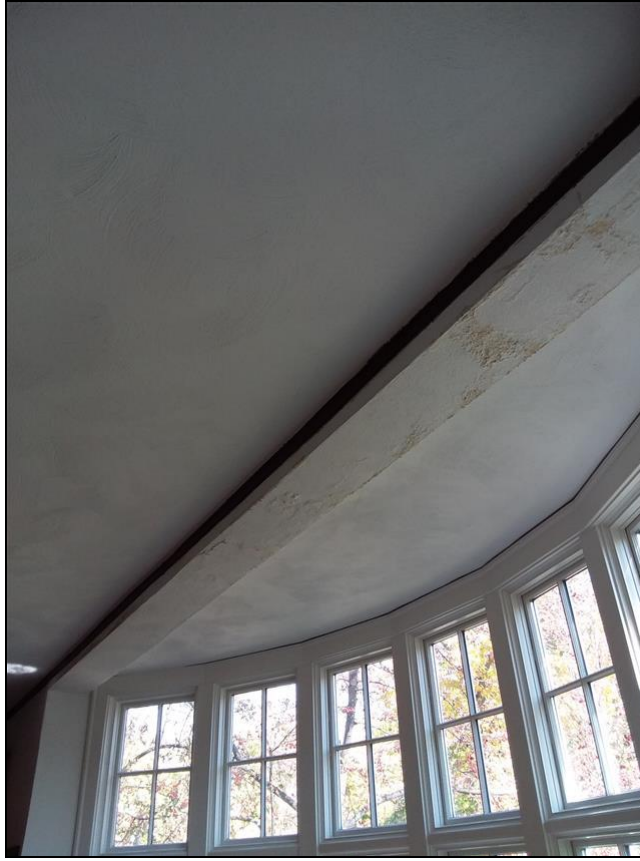
11.0 (3) The textured finish on the ceiling shows moisture stains indicating water intrusion did or still may be occurring at the living room. Thermal imaging equipment was used and did not indicate an active leak. A qualified painting contractor should repair as needed.

Water damage at ceiling

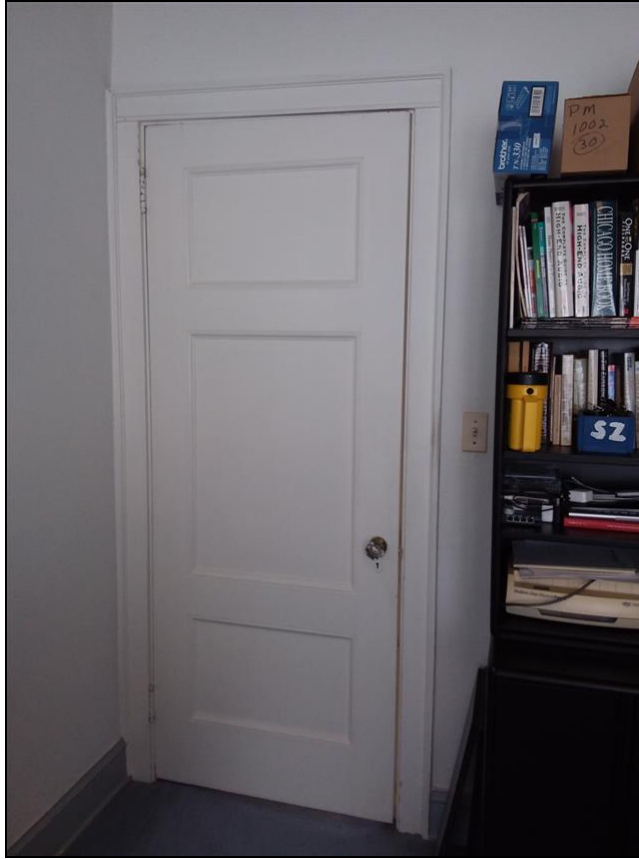
11.3 (1) The privacy door needs a strike adjustment to latch properly at the office. This is a deferred maintenance issue. A qualified contractor or handyman should repair or replace as needed.

Door will not fully close

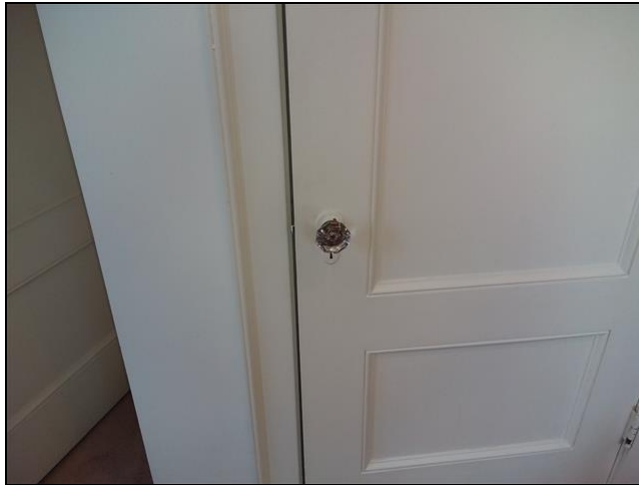
11.3 (2) The closet door needs a strike adjustment to latch properly at the rear bedroom. This is a deferred maintenance issue. A qualified contractor or handyman should repair or replace as needed.

Door will not latch

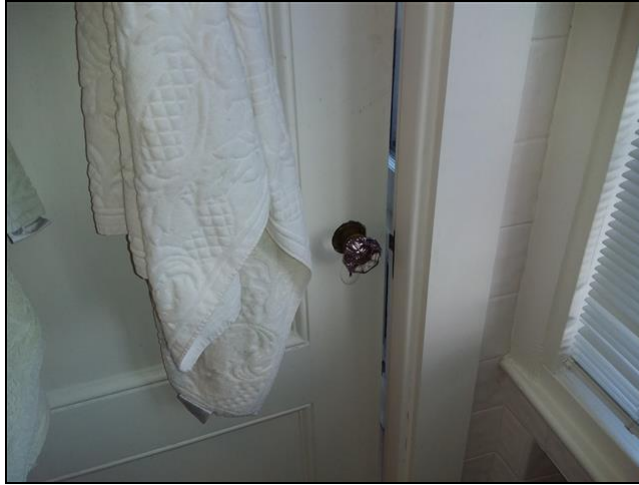
11.3 (3) The privacy door needs a strike adjustment to latch properly at the hall bath. This is a deferred maintenance issue. A qualified contractor or handyman should repair or replace as needed.

Door will not latch

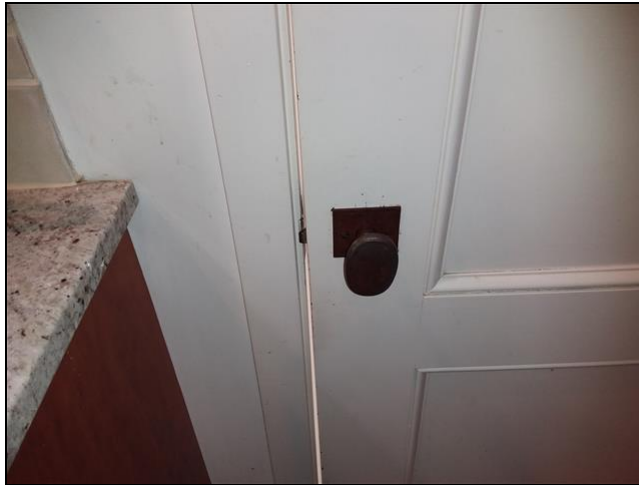
**11.3 (4)** The entry door needs a strike adjustment to latch properly at the kitchen. This is a deferred maintenance issue. A qualified contractor or handyman should repair or replace as needed.

Door will not latch

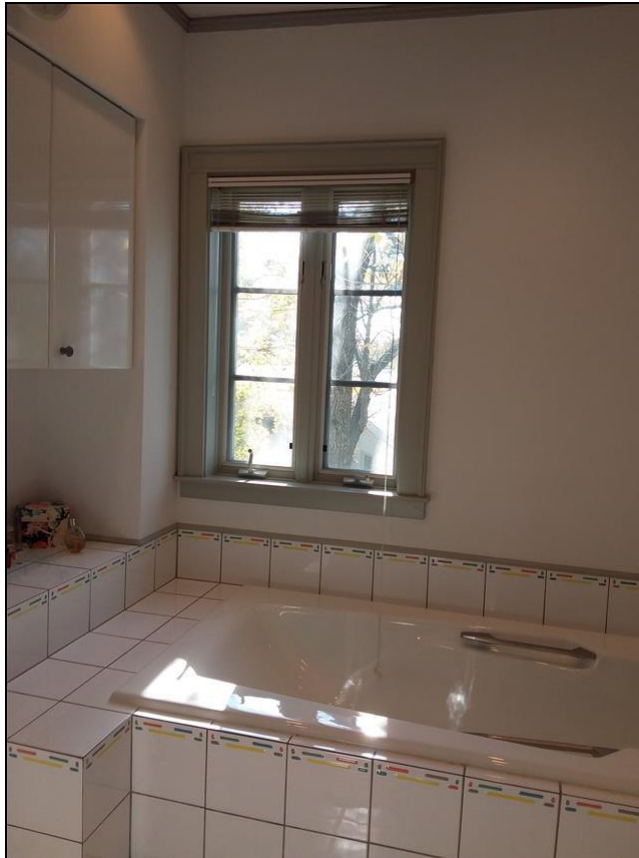
**11.4 (1)** The window above the tub is required to be tempered glass in case of a slip and fall in the tub and must display an etched label in one of the corners confirming it is tempered. That label was not apparent on this window. Some custom made windows might not have this etching or label attached, and in such case you should contact the manufacturer. Replacement of the window glass if not tempered is recommended for safety.

Window over master bath tub

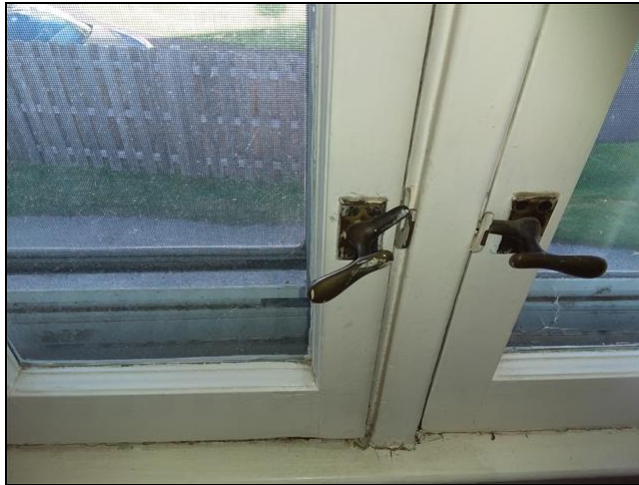
11.4 (2) Some of the latching dogs at the windows are not engaging properly. Repair is needed to prevent cold air infiltration. A qualified window contractor should evaluate further and repair as needed.

Latch will not engage

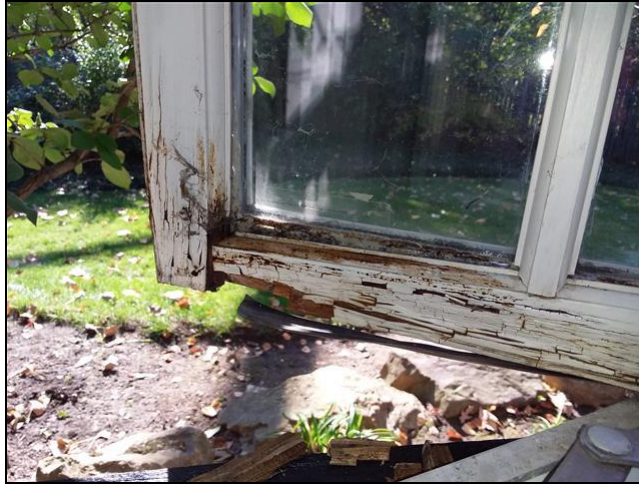
11.4 (3) One window is water damaged and rotted at the family room. Repair is needed to prevent water entry and damage to the interior wall framing. A qualified electrical contractor should evaluate further and repair or replace as needed.

Rotted wood window

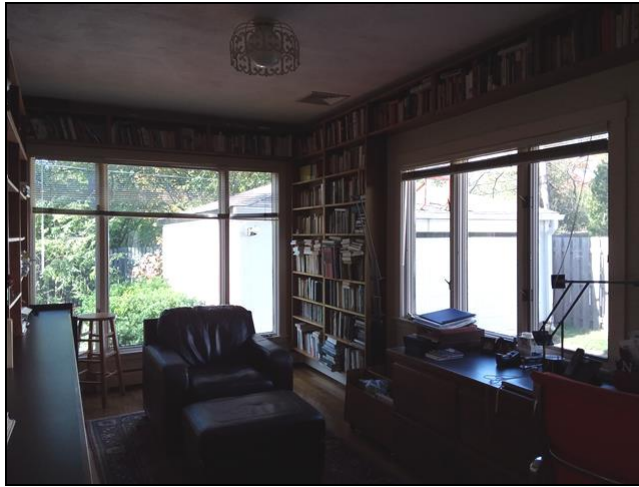
Windows will not open with control

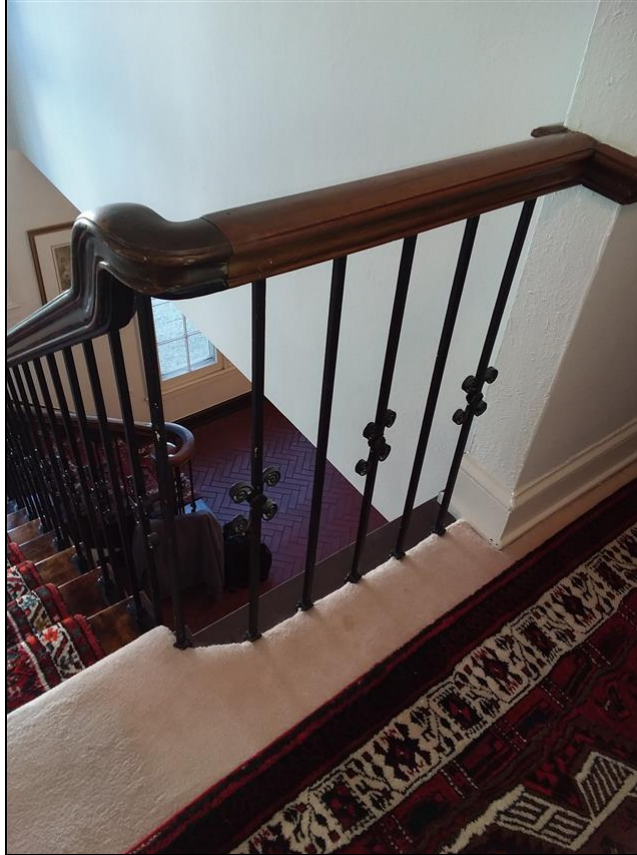
**11.5 (2)** One baluster is loose at the upstairs railing. Repair is needed for proper function. A qualified contractor or handyman should repair as needed.

Loose baluster

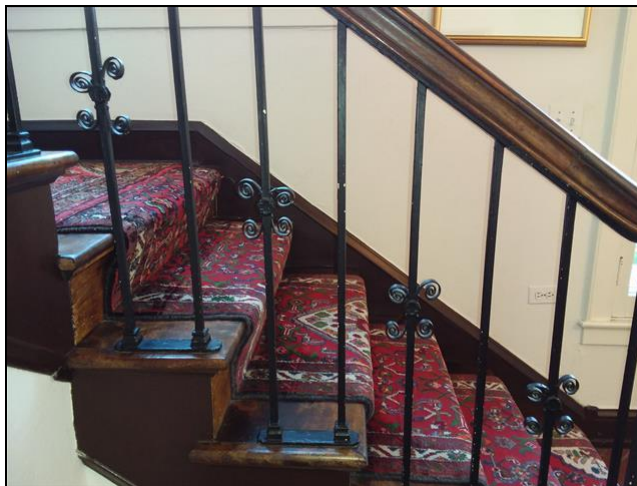
Wide spacing at stair railing
