Inspection Report

600 South St

Unit 1A

DLM Home Inspection

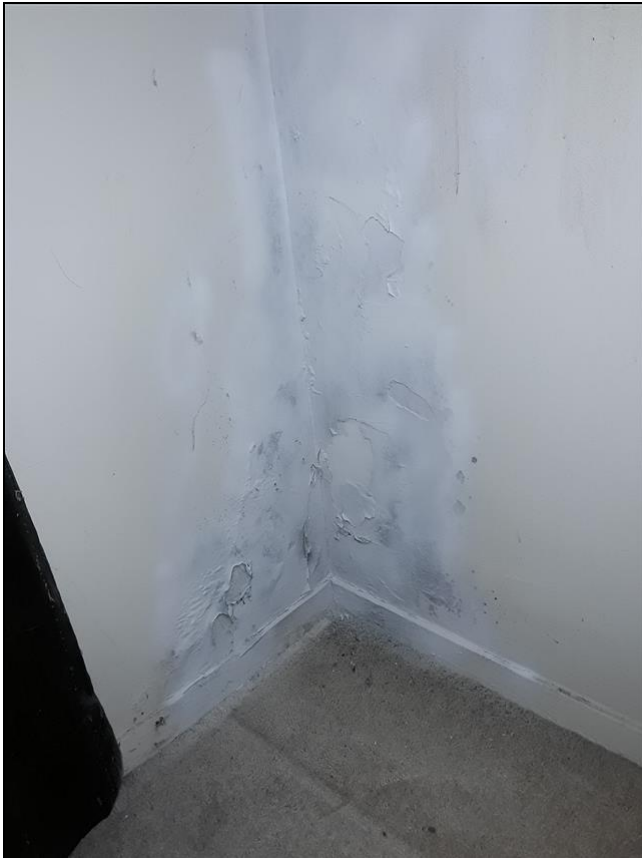
**1.1** The plaster on the wall shows moisture stains indicating water intrusion did or still may be occurring at the living room and front bedroom closet. The moisture meter was used and it recorded 19% or higher, which indicates the leak has not been corrected. A qualified contractor should evaluate further and repair as needed.

Water damage at living room wall

The plaster on the wall shows moisture stains indicating water intrusion did or still may be occurring at the living room and front bedroom closet. The moisture meter was used and it recorded 19% or higher, which indicates the leak has not been corrected. A qualified contractor should evaluate further and repair as needed.

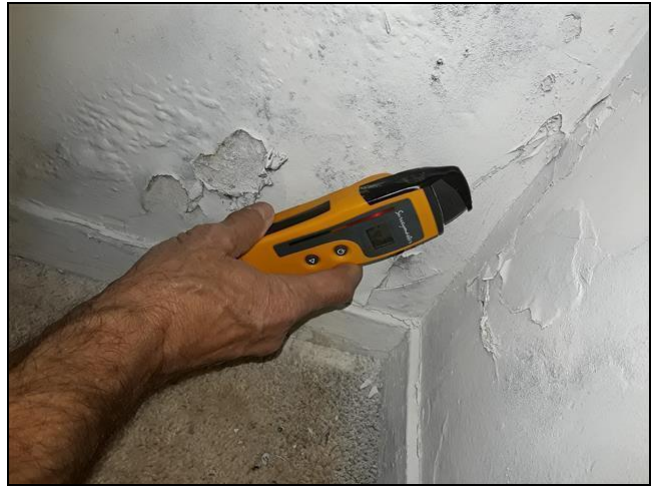
Elevated moisture levels confirmed

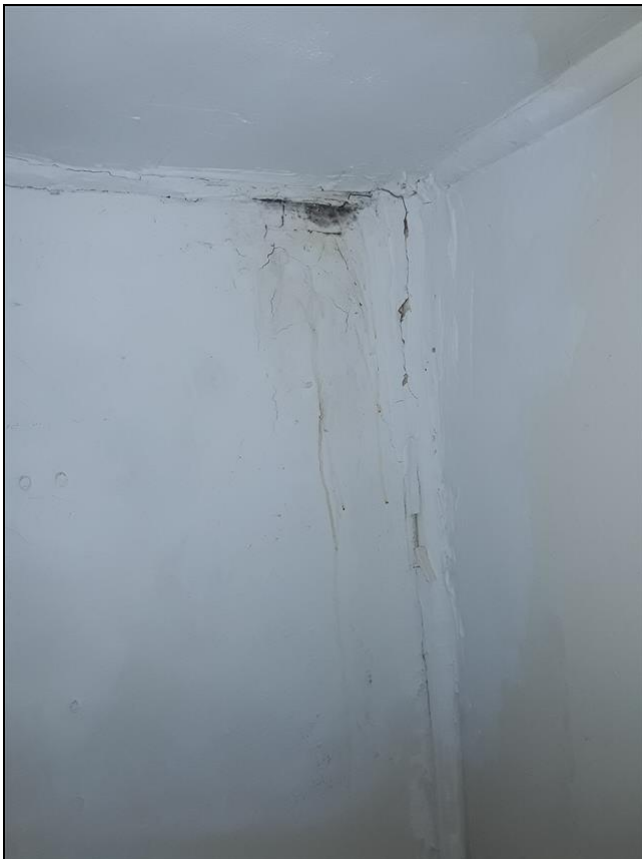
Water damage at closet

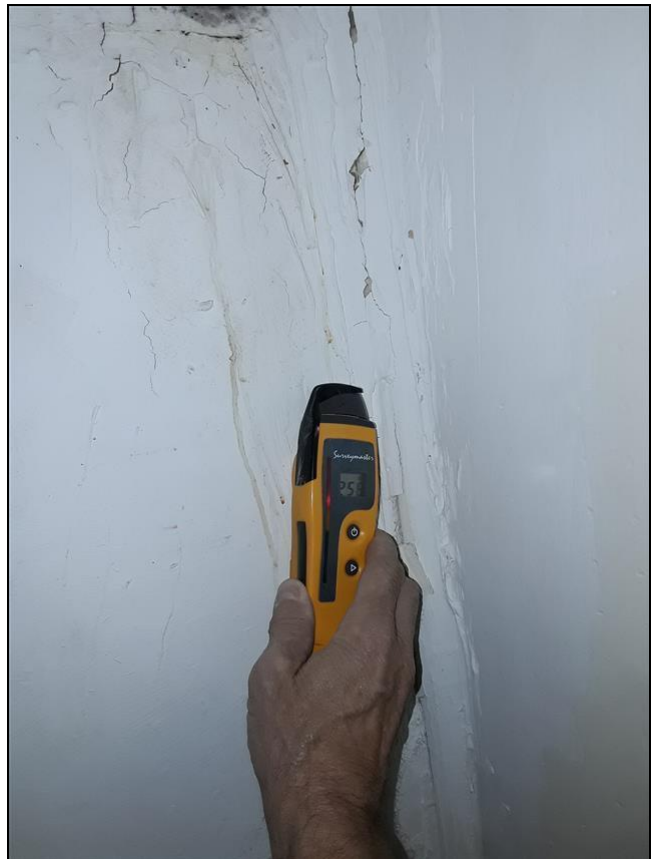
Elevated moisture levels confirmed

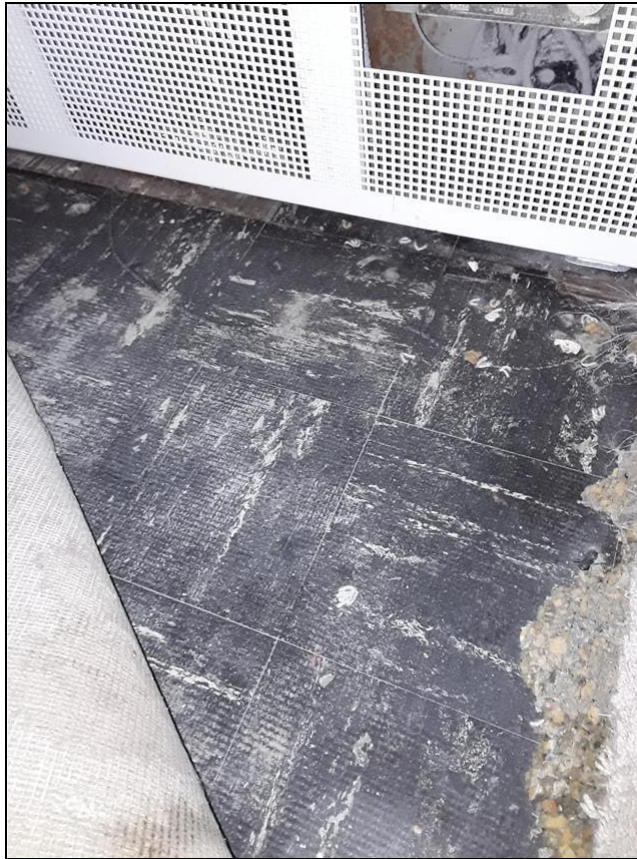
**1.2 (1)** The floor tiling in the home is of a size and style that is consistent with asbestos content. Some loose and damage tiles were noted which indicates the possibility that asbestos fibers have been released. Further evaluation by a licensed and competent environmental remediation contractor is recommended in order to determine if any hazard exists and what remedial steps may be prudent.

Asbestos floor tiles

(1) The floor tiling in the home is of a size and style that is consistent with asbestos content. Some loose and damage tiles were noted which indicates the possibility that asbestos fibers have been released. Further evaluation by a licensed and competent environmental remediation contractor is recommended in order to determine if any hazard exists and what remedial steps may be prudent.

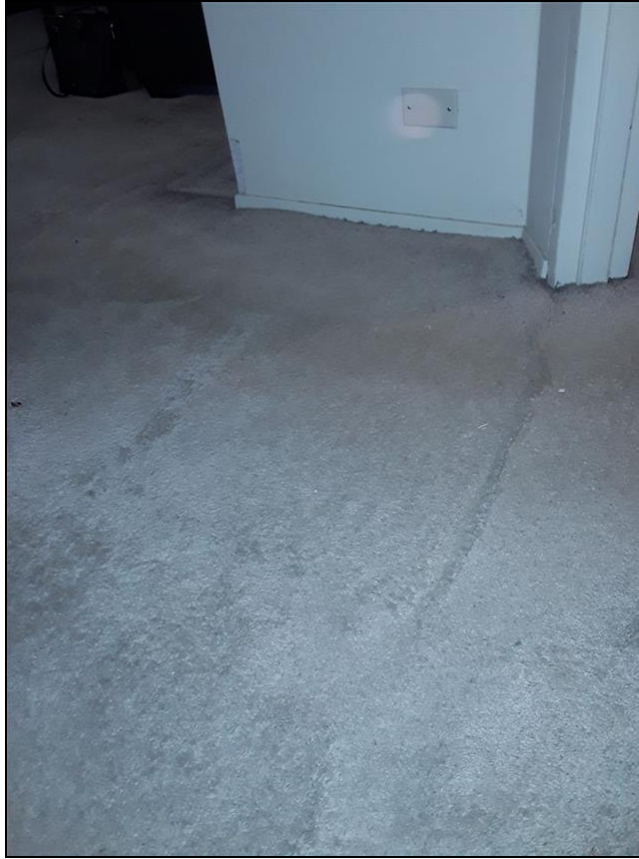
**1.2 (2)** The wood subfloor is loose or damaged at the hallway, direct access to the defect is blocked by carpet. Repair is needed to prevent risk of injury and to provide proper support to the floor. A qualified contractor should evaluate further and repair as needed.

Loose or damaged wood sub-floor

(2) The wood subfloor is loose or damaged at the hallway, direct access to the defect is blocked by carpet. Repair is needed to prevent risk of injury and to provide proper support to the floor. A qualified contractor should evaluate further and repair as needed.

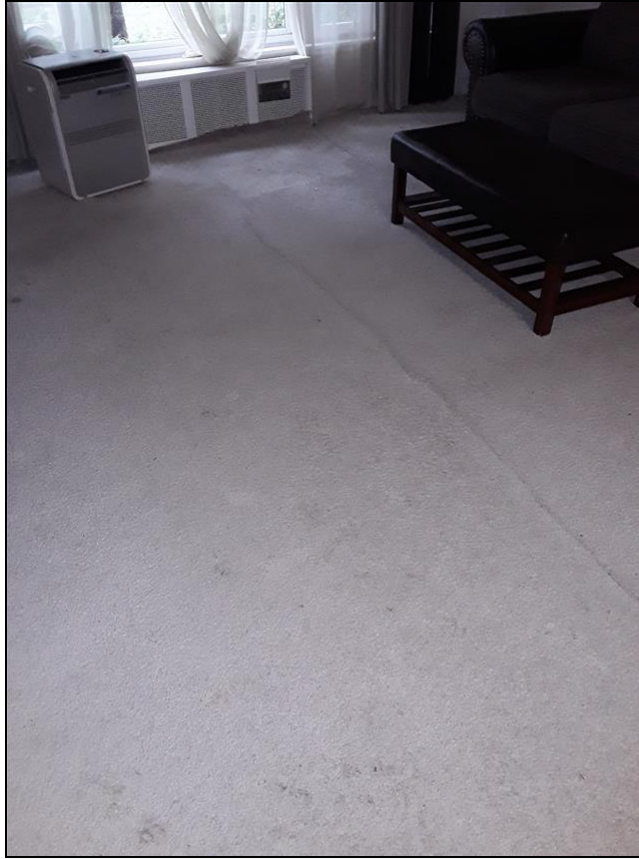
1.2 (3) The carpet is loose or baggy and not stretched for a tight installation throughout the home, a large tear in the carpet was noted in the living room. Repair is needed to prevent trip and fall injuries and for proper appearance. A qualified flooring contractor should evaluate further and repair or replace as needed.

Old, loose and torn carpet

(3) The carpet is loose or baggy and not stretched for a tight installation throughout the home, a large tear in the carpet was noted in the living room. Repair is needed to prevent trip and fall injuries and for proper appearance. A qualified flooring contractor should evaluate further and repair or replace as needed.

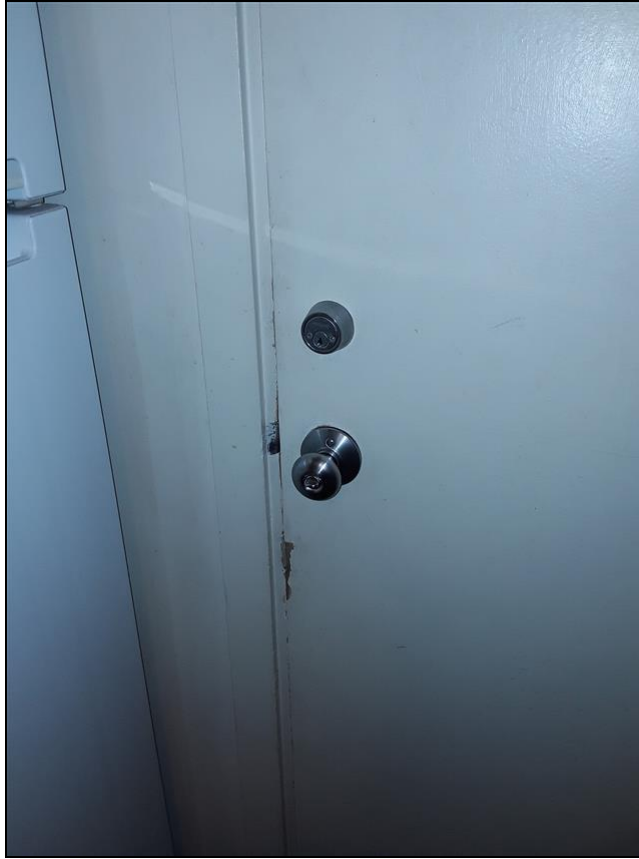
1.3 Double-keyed deadbolts locks can pose a risk of entrapment in an emergency. No special tools or knowledge should be needed to exit the home in an emergency. The interior deadbolt lock should be replaced with one using a thumb latch.

Keyed deadbolt at kitchen

Double-keyed deadbolts locks can pose a risk of entrapment in an emergency. No special tools or knowledge should be needed to exit the home in an emergency. The interior deadbolt lock should be replaced with one using a thumb latch.

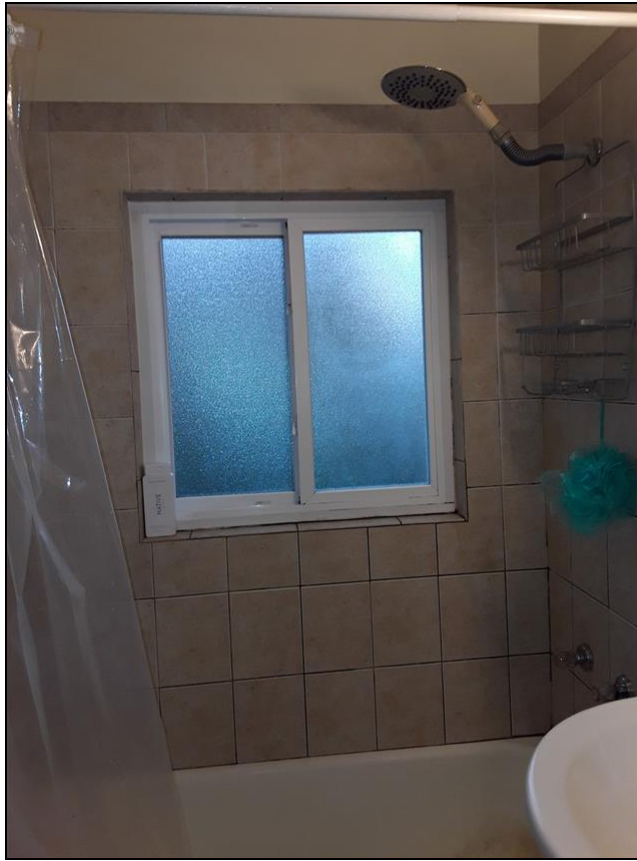
**1.4** The window above the tub is required to be tempered glass in case of a slip and fall in the tub and must display an etched label in one of the corners confirming it is tempered. That label was not apparent on this window. Some custom made windows might not have this etching or label attached, and in such case you should contact the manufacturer. Replacement of the window glass if not tempered is recommended for safety.

Window over hall bath tub

The window above the tub is required to be tempered glass in case of a slip and fall in the tub and must display an etched label in one of the corners confirming it is tempered. That label was not apparent on this window. Some custom made windows might not have this etching or label attached, and in such case you should contact the manufacturer. Replacement of the window glass if not tempered is recommended for safety.

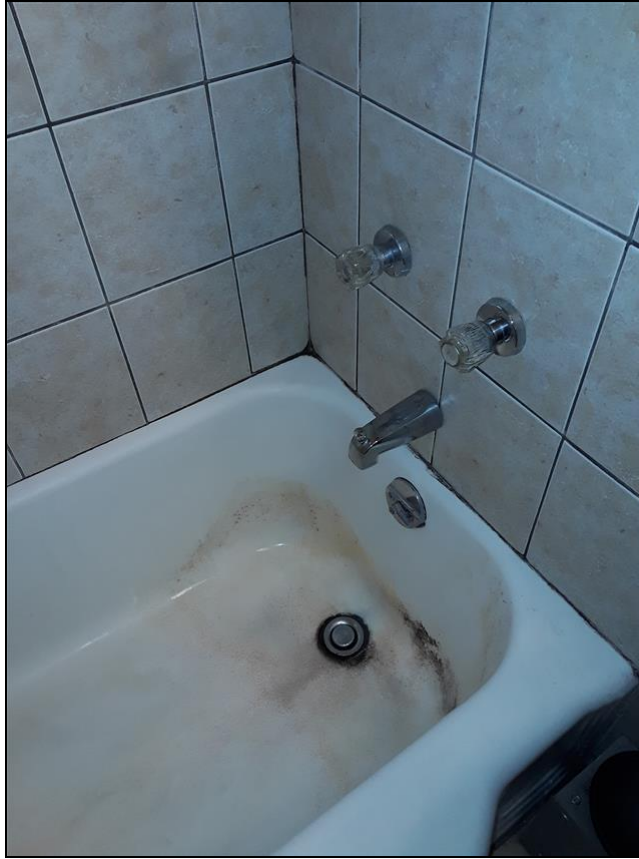
**2.1** The caulked joints at the tile intersections and grout joints are exhibiting signs of mold growth. The joints at the inside corners of tub/shower surrounds and at tub-to-tile intersections should be raked out, all surfaces thoroughly cleaned with a mold control product (Concrobium brand), dried and new color-matched, 100% silicone caulk used in order to prevent future mildew staining, leakage and damage to the tile substrate. In general, all dissimilar materials in contact with ceramic tile should be protected from cracking and moisture penetration through the use of appropriate caulking methods and materials.

Mold growth at tub

The caulked joints at the tile intersections and grout joints are exhibiting signs of mold growth. The joints at the inside corners of tub/shower surrounds and at tub-to-tile intersections should be raked out, all surfaces thoroughly cleaned with a mold control product (Concrobium brand), dried and new color-matched, 100% silicone caulk used in order to prevent future mildew staining, leakage and damage to the tile substrate. In general, all dissimilar materials in contact with ceramic tile should be protected from cracking and moisture penetration through the use of appropriate caulking methods and materials.

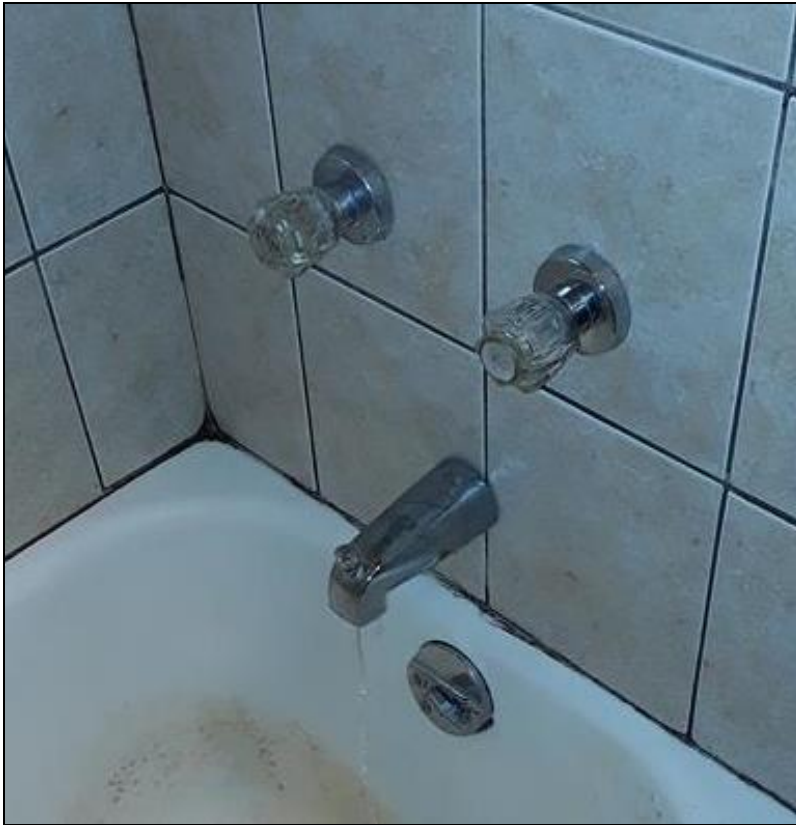
2.2 (1) The tub faucet drips continuously at the hall bath. Repair is needed to prevent water losses. A qualified plumbing contractor should evaluate further and repair as needed.

Water drips continuously

(1) The tub faucet drips continuously at the hall bath. Repair is needed to prevent water losses. A qualified plumbing contractor should evaluate further and repair as needed.
-

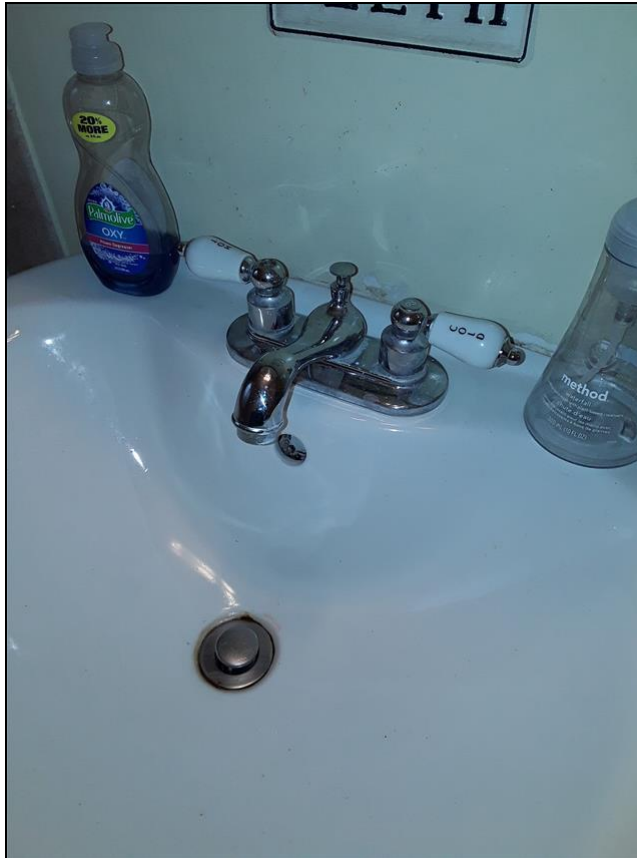
2.2 (2) The sink faucet is loose at the hall bath. Repairs are needed to prevent pipe breakage and damage to adjacent finishes. A qualified plumbing contractor should repair or replace as needed.

Loose faucet

(2) The sink faucet is loose at the hall bath. Repairs are needed to prevent pipe breakage and damage to adjacent finishes. A qualified plumbing contractor should repair or replace as needed.

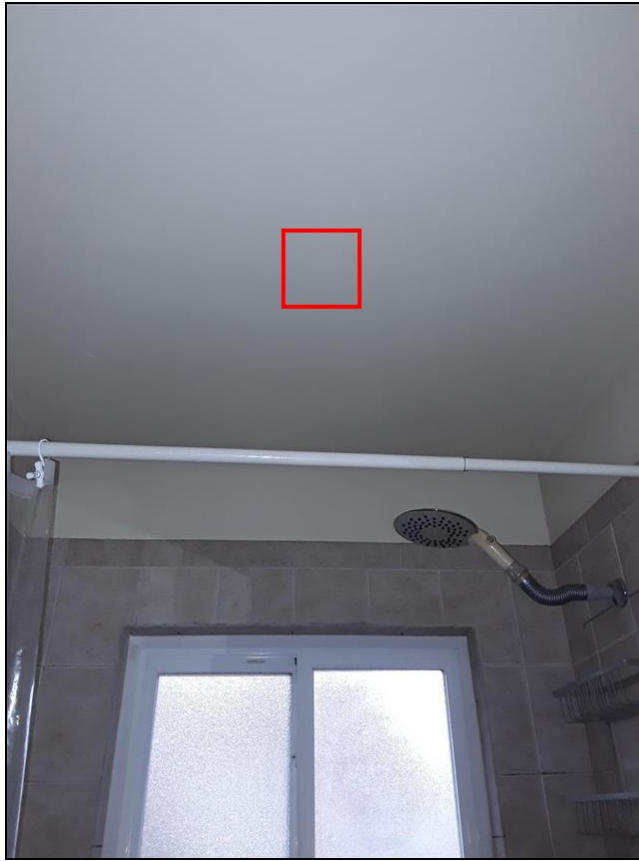
2.4 The installation of a ducted bathroom exhaust fan is recommended in each bathroom in order to provide for the safe and effective removal of moisture and odors. While local building practices may allow the use of a bathroom window for ventilation, this method is ineffective, uncomfortable in the winter, and wastes energy. High quality, quiet, exhaust fans (preferably controlled with a timer switch) should be installed by a qualified contractor.

Add bath exhaust fan

The installation of a ducted bathroom exhaust fan is recommended in each bathroom in order to provide for the safe and effective removal of moisture and odors. While local building practices may allow the use of a bathroom window for ventilation, this method is ineffective, uncomfortable in the winter, and wastes energy. High quality, quiet, exhaust fans (preferably controlled with a timer switch) should be installed by a qualified contractor.

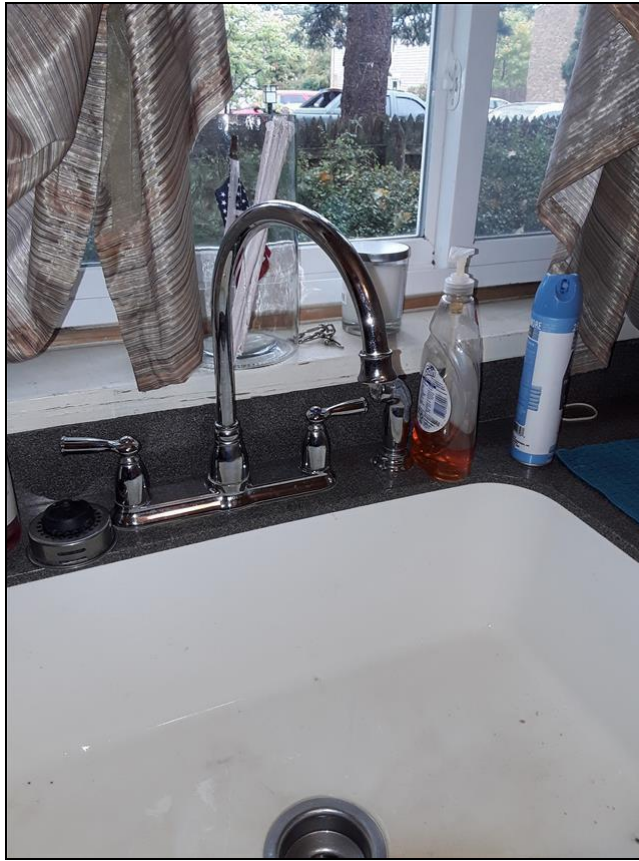
**3.1** The faucet drips continuously at the kitchen sink. Repairs are needed to prevent water losses. A qualified plumbing contractor should repair or replace as needed.

Faucet drips continuously

The faucet drips continuously at the kitchen sink. Repairs are needed to prevent water losses. A qualified plumbing contractor should repair or replace as needed.

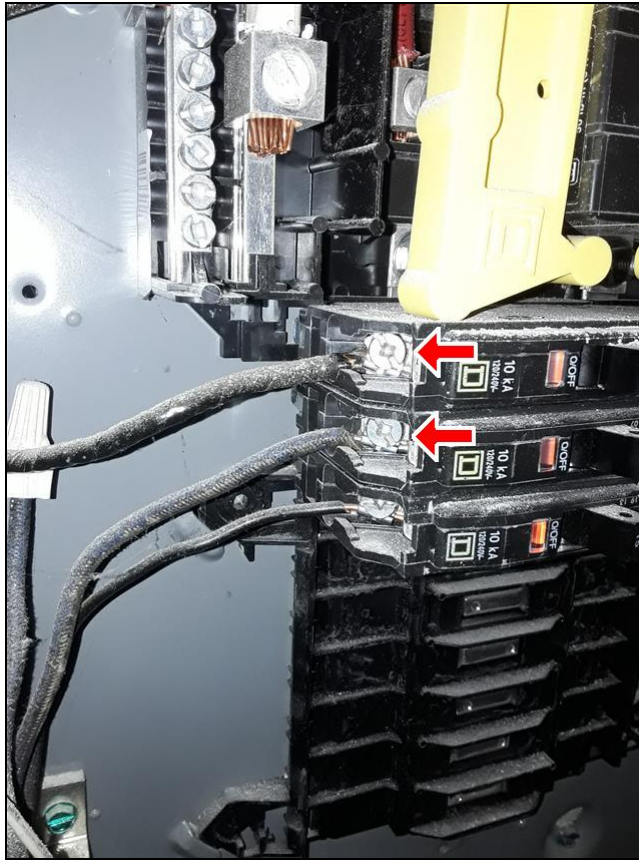
**4.2** Aluminum wire is installed on 120 VAC branch electrical circuits in the subject house (Some tinned copper wiring can have the appearance of aluminum wiring). These single strand, branch circuit aluminum wires were used widely in houses during the mid 1960s and 1970s. According to the U.S. Consumer Product Safety Commission, problems due to expansion can cause overheating at connections between the wire and devices (switches and outlets) or at splices, which has resulted in fires. For further information on aluminum wiring contact the U.S. Consumer Product Safety Commission via the Internet at <http://www.cpsc.gov/> . It is recommended that the electrical system be evaluated by a licensed electrician.

Aluminum branch circuit wiring

Aluminum wire is installed on 120 VAC branch electrical circuits in the subject house (Some tinned copper wiring can have the appearance of aluminum wiring). These single strand, branch circuit aluminum wires were used widely in houses during the mid 1960s and 1970s. According to the U.S. Consumer Product Safety Commission, problems due to expansion can cause overheating at connections between the wire and devices (switches and outlets) or at splices, which has resulted in fires. For further information on aluminum wiring contact the U.S. Consumer Product Safety Commission via the Internet at <http://www.cpsc.gov/> . It is recommended that the electrical system be evaluated by a licensed electrician.

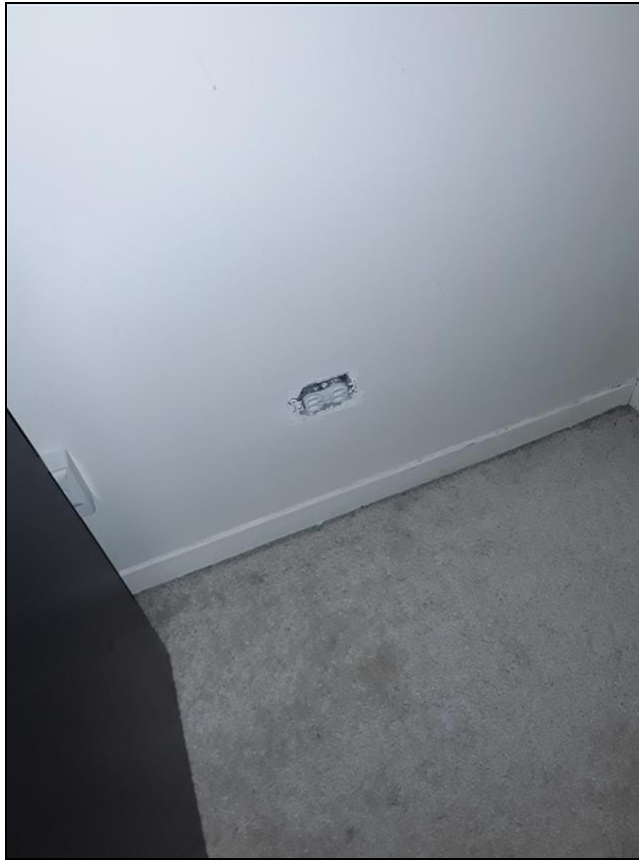
**4.3** (1) One outlet is missing a cover-plate in the living room. This is a safety issue that needs to be corrected. A qualified licensed electrician should repair as needed.

Missing outlet cover

(1) One outlet is missing a cover-plate in the living room. This is a safety issue that needs to be corrected. A qualified licensed electrician should repair as needed.
-

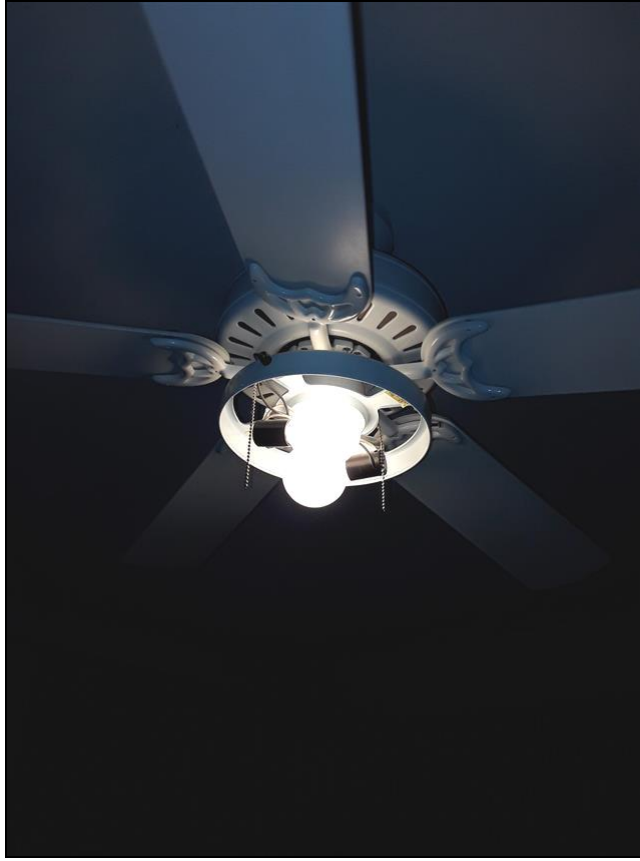
**4.3** (2) The light fixture is missing a globe at the front bedroom. This is a safety issue that needs to be corrected. A qualified electrical contractor should correct as needed.

Missing light globe

(2) The light fixture is missing a globe at the front bedroom. This is a safety issue that needs to be corrected. A qualified electrical contractor should correct as needed.
-

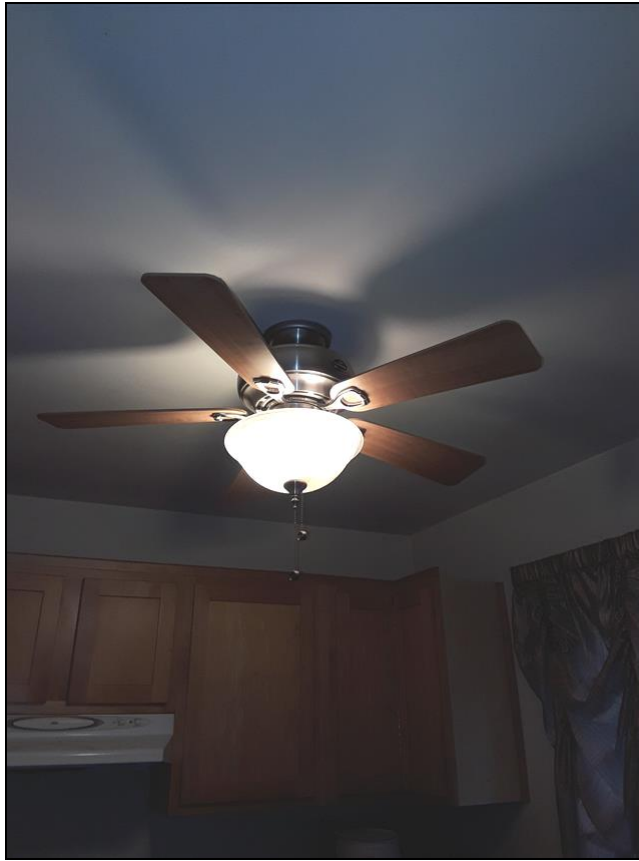
4.3 (3) The ceiling fan did not function when tested in the kitchen. A qualified licensed electrician should repair or replace as needed.

Ceiling fan not working

(3) The ceiling fan did not function when tested in the kitchen. A qualified licensed electrician should repair or replace as needed.

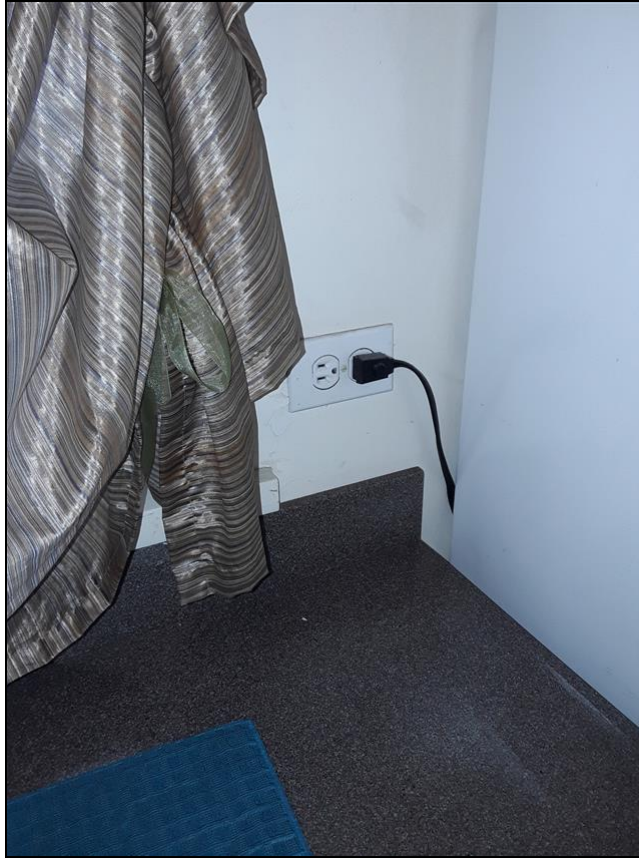
**4.4** It is recommended that all electrical receptacles at kitchen counters, in bathrooms, garages and all exterior locations that are not already GFCI protected be upgraded to GFCI protected outlets by a licensed and competent electrician in order to reduce the risk of electrical shock and injury.

Non-GFCI kitchen counter outlet

It is recommended that all electrical receptacles at kitchen counters, in bathrooms, garages and all exterior locations that are not already GFCI protected be upgraded to GFCI protected outlets by a licensed and competent electrician in order to reduce the risk of electrical shock and injury.

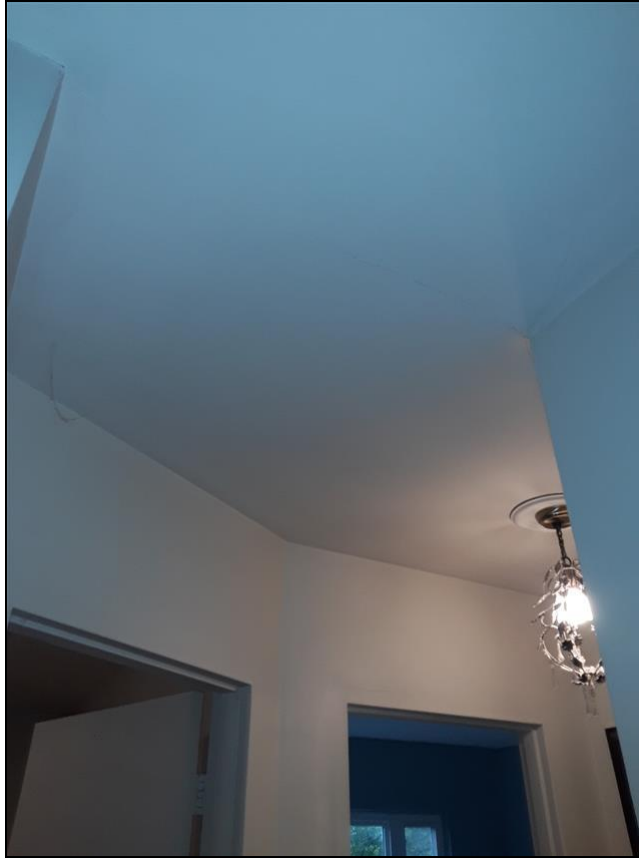
**4.5** There are no smoke or CO detectors installed in the home. It is recommended each level of living space have smoke and carbon monoxide detectors installed and operational. The installation of hard-wired smoke detectors in each bedroom is recommended as is the inter-connecting of all smoke and CO detectors. This is recommended so that an alarm in any part of the home would be able to alert a sleeping occupant in any bedroom. A qualified electrical contractor should upgrade as required.

Add smoke and CO detectors

There are no smoke or CO detectors installed in the home. It is recommended each level of living space have smoke and carbon monoxide detectors installed and operational. The installation of hard-wired smoke detectors in each bedroom is recommended as is the inter-connecting of all smoke and CO detectors. This is recommended so

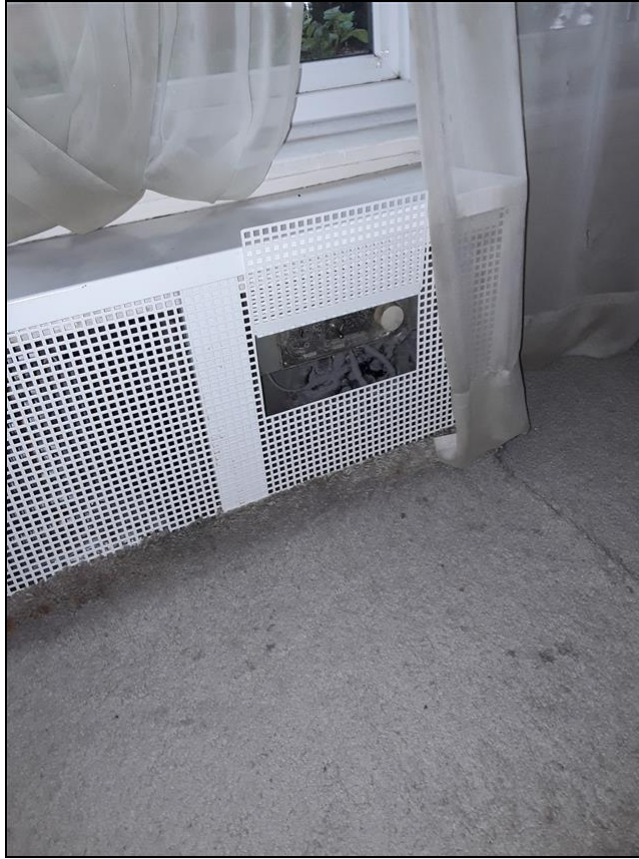
**6.1 (1)** The fan is noisy when operating at the living room heating unit. This can indicate a defective motor or bearings. A qualified HVAC contractor should evaluate further and repair or replace as needed.

Noisy fan operation

(1) The fan is noisy when operating at the living room heating unit. This can indicate a defective motor or bearings. A qualified HVAC contractor should evaluate further and repair or replace as needed.
-

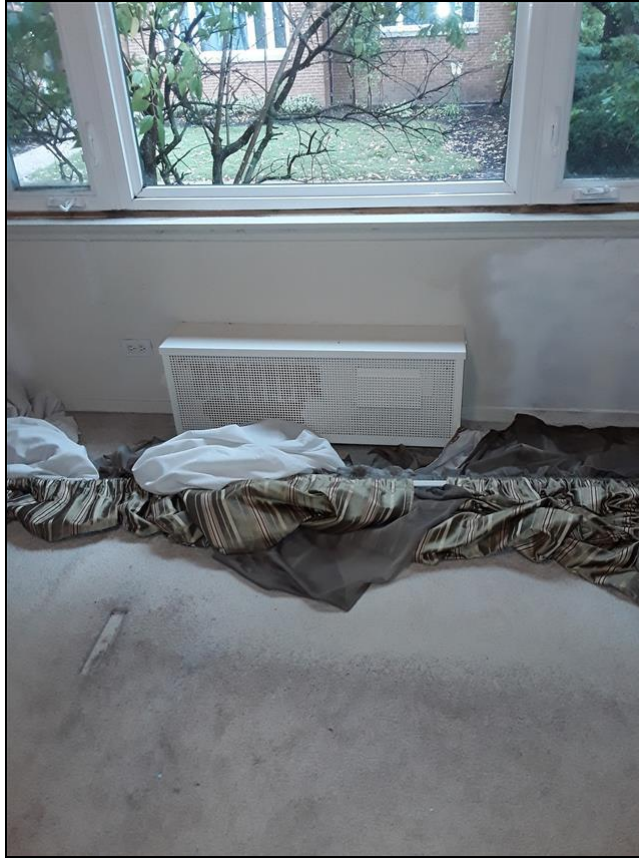
6.1 (2) The HVAC unit fan at the front bedroom did not function when tested. Repair is needed to provide heat in the winter. A qualified HVAC contractor should evaluate further and repair or replace as needed.

Fan not working

(2) The HVAC unit fan at the front bedroom did not function when tested. Repair is needed to provide heat in the winter. A qualified HVAC contractor should evaluate further and repair or replace as needed.
