# Inspection Report

1234 Main St

Unit #3

Anytown IL 66666

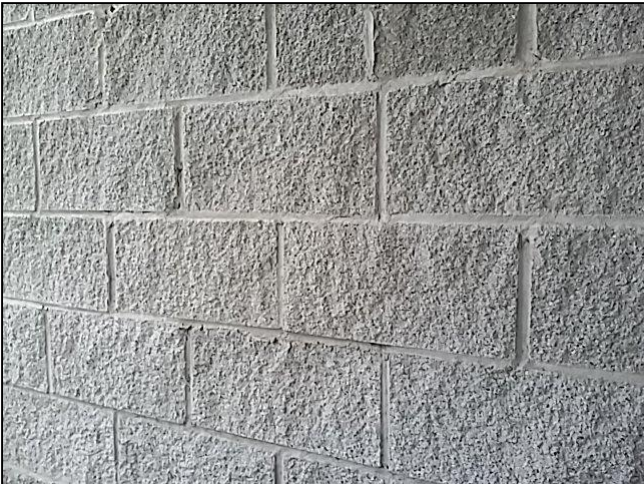
**1.0 (1)** Concrete block is a highly porous building material. The failure to maintain the exterior concrete block walls can lead to moisture intrusion, wood rot, mold growth, structural damage and (if severely neglected for a prolonged period) structural floor collapse. The building codes call for it to be pre-treated with water repellent at the factory and for the mortar used in it's installation to also be water repellent. Regular evaluation for moisture absorption and application of a surface-applied water repellent treatment is required every several years in order to protect against moisture penetration. The client should request all pertinent documentation regarding past wall leakage, recent repairs, any recent application of exterior masonry sealants and preventive maintenance strategies.

Split-faced block exterior walls

(1) Concrete block is a highly porous building material. The failure to maintain the exterior concrete block walls can lead to moisture intrusion, wood rot, mold growth, structural damage and (if severely neglected for a prolonged period) structural floor collapse. The building codes call for it to be pre-treated with water repellent at the factory and for the mortar used in it's installation to also be water repellent. Regular evaluation for moisture absorption and application of a surface-applied water repellent treatment is required every several years in order to protect against moisture penetration. The client should request all pertinent documentation regarding past wall leakage, recent repairs, any recent application of exterior masonry sealants and preventive maintenance strategies.

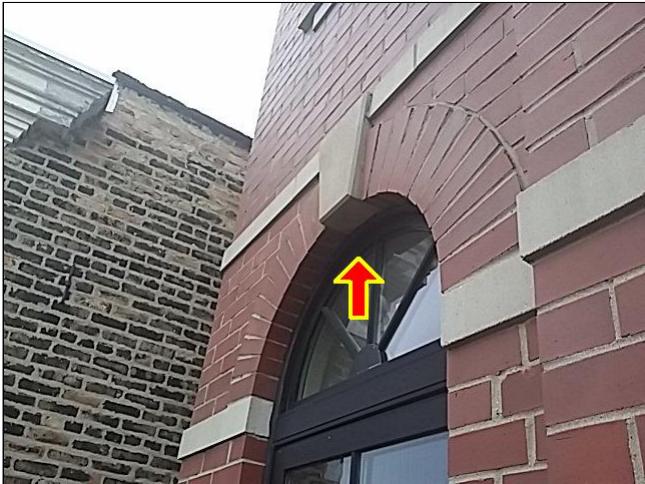
**1.0 (2)** The masonry wall flashings are either missing or improperly installed. The flashings should protrude from the wall by at least 1/4 inch at the following locations: the top of the foundation wall; above the masonry pockets where the floor joists are set into the concrete block; above and below every window and door. Missing or improperly installed wall flashing can allow moisture to enter the home and cause rot, mold growth, and structural damage. The exterior masonry walls of this structure should be evaluated and repaired by a licensed and competent masonry contractor.

No visible flashing above windows

- (2) The masonry wall flashings are either missing or improperly installed. The flashings should protrude from the wall by at least 1/4 inch at the following locations: the top of the foundation wall; above the masonry pockets where the floor joists are set into the concrete block; above and below every window and door. Missing or improperly installed wall flashing can allow moisture to enter the home and cause rot, mold growth, and structural damage. The exterior masonry walls of this structure should be evaluated and repaired by a licensed and competent masonry contractor.

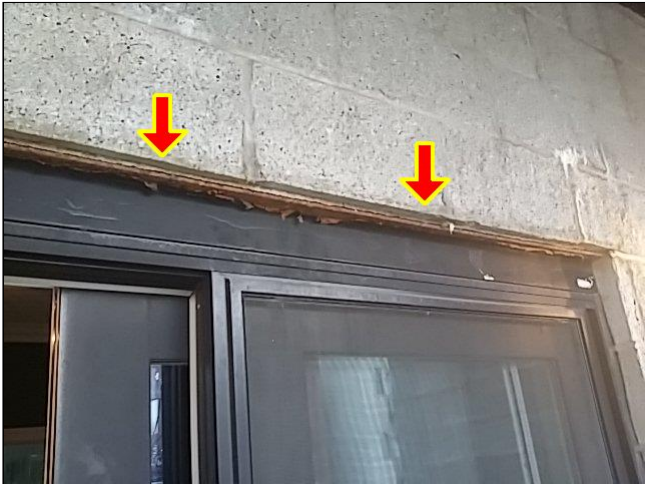
No visible flashing above doors

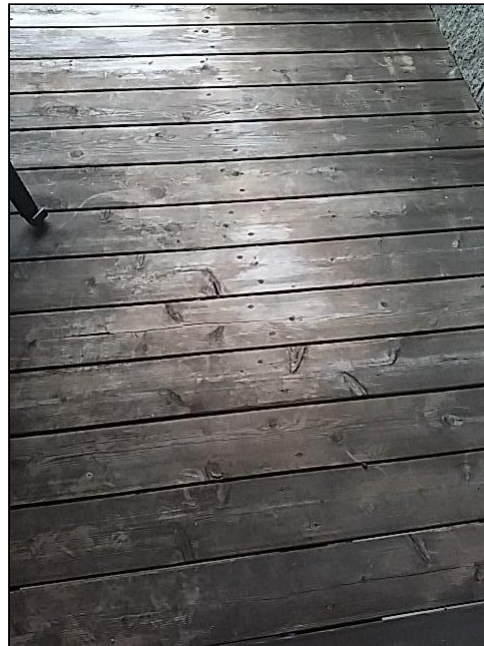
Weathered deck surface

**1.4** All exterior wooden deck surfaces should be professionally cleaned and sealed against weather in order to extend the service life of the materials. A qualified deck restoration contractor should correct as needed.

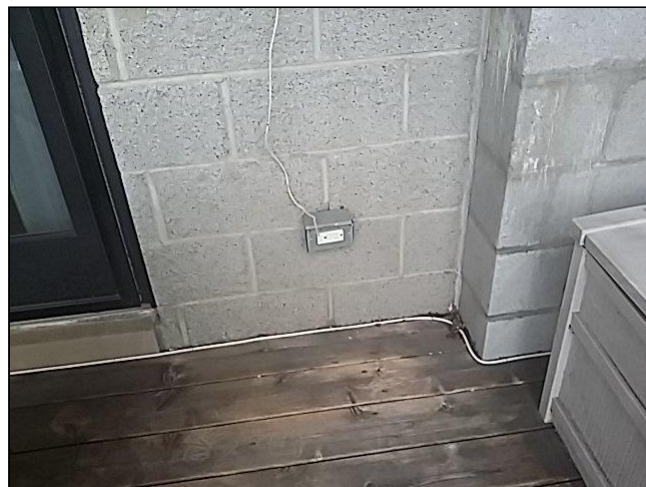
**1.7** The GFCI (Ground Fault Circuit Interrupter) outlet at the rear exterior is missing a cover. This is a safety issue that needs to be corrected. A qualified licensed electrician should correct as needed.

Missing outlet cover

- The GFCI (Ground Fault Circuit Interrupter) outlet at the rear exterior is missing a cover. This is a safety issue that needs to be corrected. A qualified licensed electrician should correct as needed.

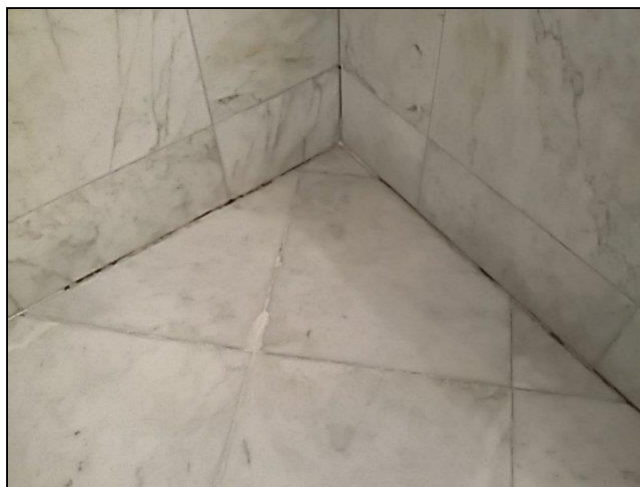
🔧 **4.1 (1)** The caulked joints at the tile intersections and grout joints are exhibiting signs of mold growth. The joints at the inside corners of tub/shower surrounds and at tub-to-tile intersections should be raked out, all surfaces thoroughly cleaned with a mold control product (Concrobium brand), dried and new color-matched, 100% silicone caulk used in order to prevent future mildew staining, leakage and damage to the tile substrate. In general, all dissimilar materials in contact with ceramic tile should be protected from cracking and moisture penetration through the use of appropriate caulking methods and materials.

Mold growth at master bath shower surround

- (1) The caulked joints at the tile intersections and grout joints are exhibiting signs of mold growth. The joints at the inside corners of tub/shower surrounds and at tub-to-tile intersections should be raked out, all surfaces thoroughly cleaned with a mold control product (Concrobium brand), dried and new color-matched, 100% silicone caulk used in order to prevent future mildew staining, leakage and damage to the tile substrate. In general, all dissimilar materials in contact with ceramic tile should be protected from cracking and moisture penetration through the use of appropriate caulking methods and materials.

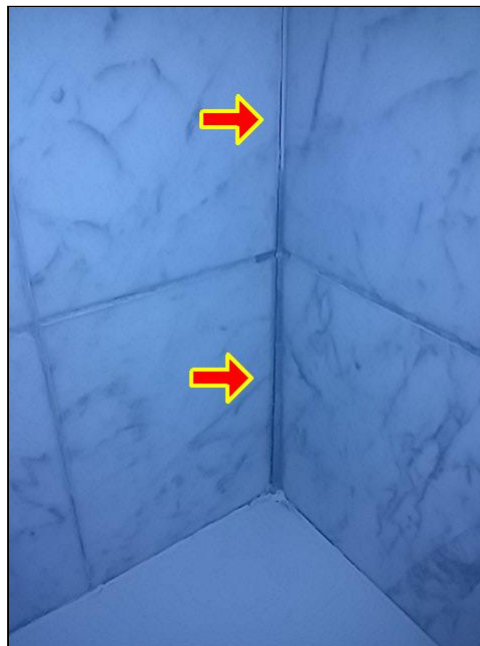
🔧 **4.1 (2)** The cracked grout joints at the hall bath tub surround should be replaced to prevent water damage to the tile substrate. A qualified tile contractor should repair as needed.

Repair cracked grout

(2) The cracked grout joints at the hall bath tub surround should be replaced to prevent water damage to the tile substrate. A qualified tile contractor should repair as needed.
-

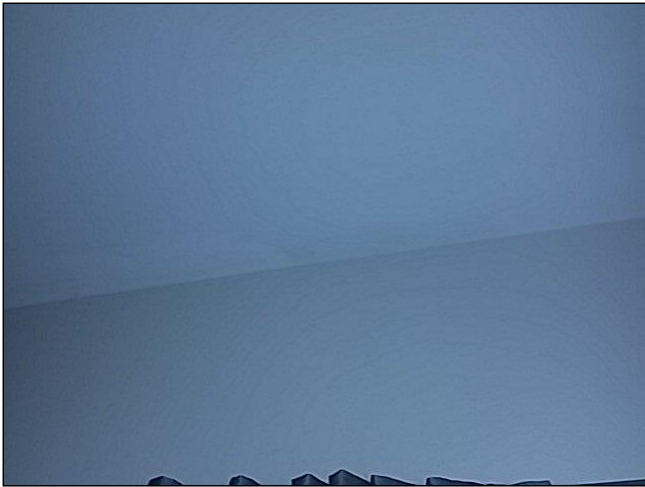
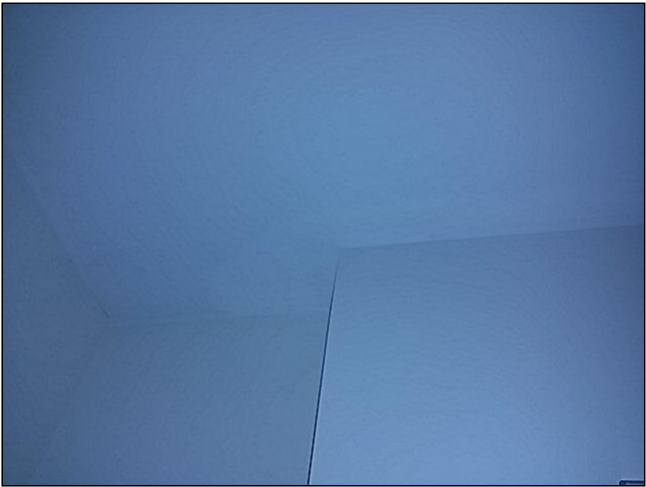
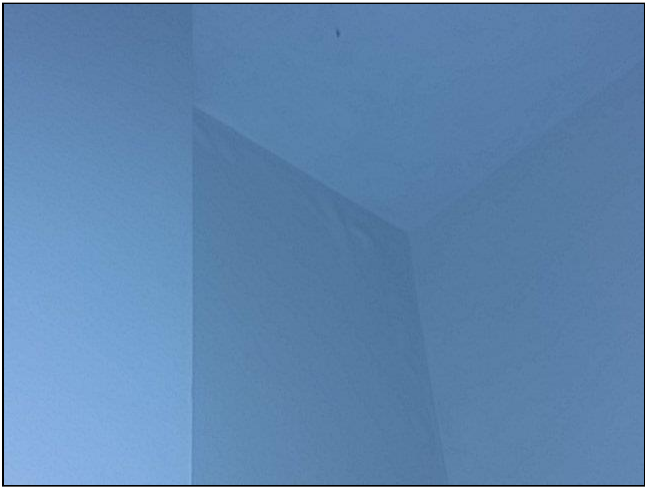
**4.1** (3) The drywall on the wall and ceiling shows moisture stains, blistering and previous repairs indicating moisture intrusion did or still may occur at the 2nd bedroom. The moisture meter was used and it did not indicate an active leak. A qualified painting contractor should repair as needed.

Moisture staining at ceiling

Previous ceiling repair

Blistered drywall

(3) The drywall on the wall and ceiling shows moisture stains, blistering and previous repairs indicating moisture intrusion did or still may occur at the 2nd bedroom. The moisture meter was used and it did not indicate an active leak. A qualified painting contractor should repair as needed.
-

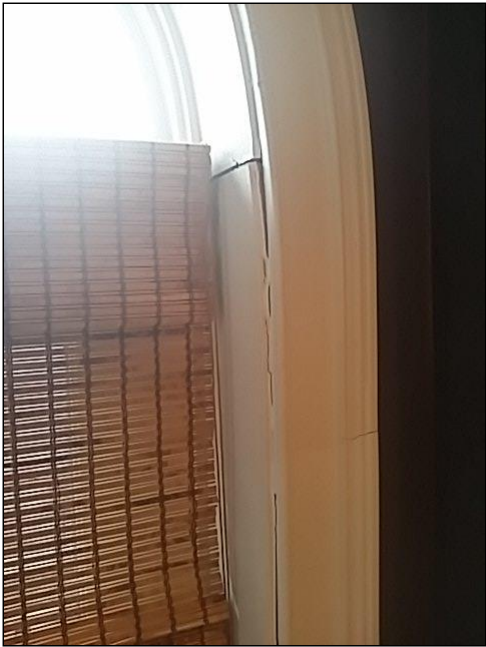
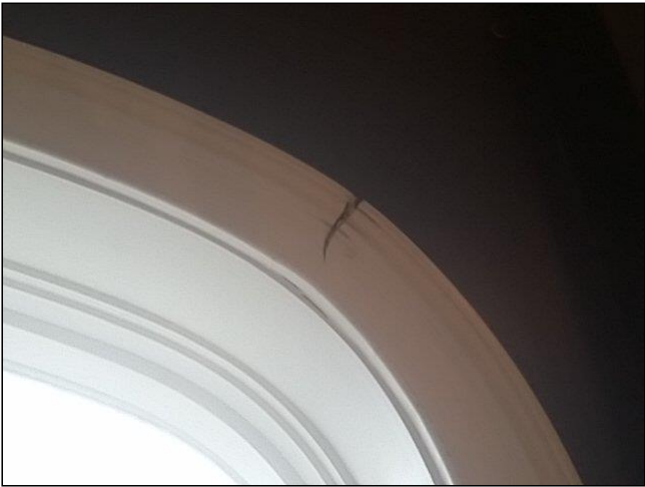
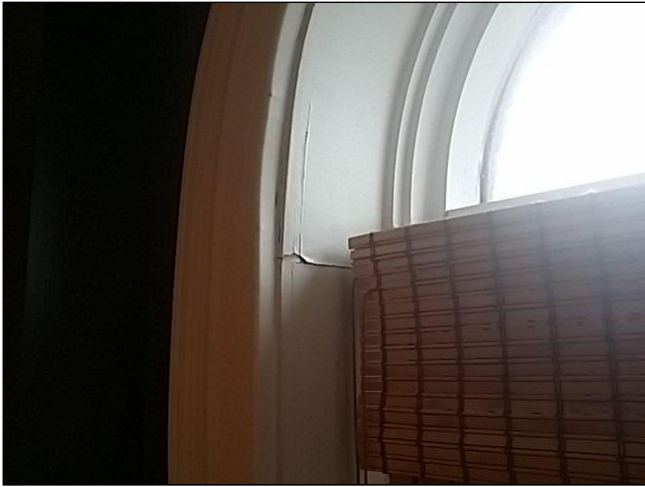
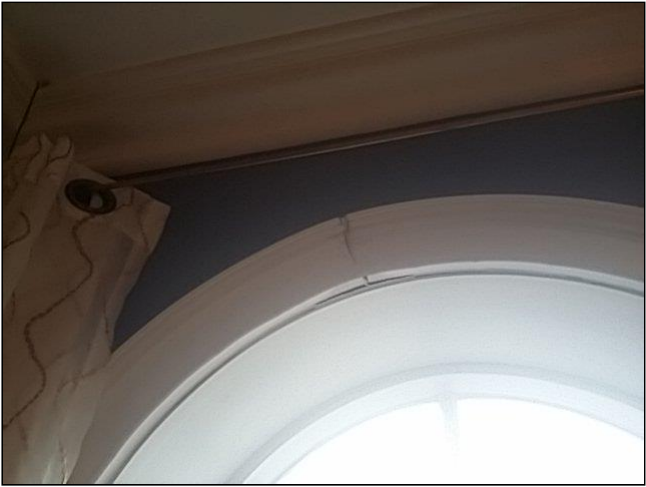
**4.1** (4) The wood trim is water damaged at the front living room wall. A qualified masonry contractor should evaluate the exterior in this area to determine where water is entering and repair as needed to prevent additional damage. A qualified carpentry contractor should repair the interior damage as needed

Moisture damage at wood trim

(4) The wood trim is water damaged at the front living room wall. A qualified masonry contractor should evaluate the exterior in this area to determine where water is entering and repair as needed to prevent additional damage. A qualified carpentry contractor should repair the interior damage as needed

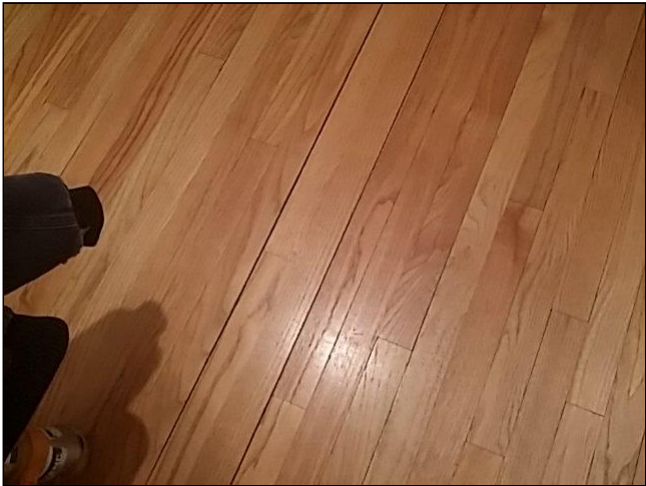
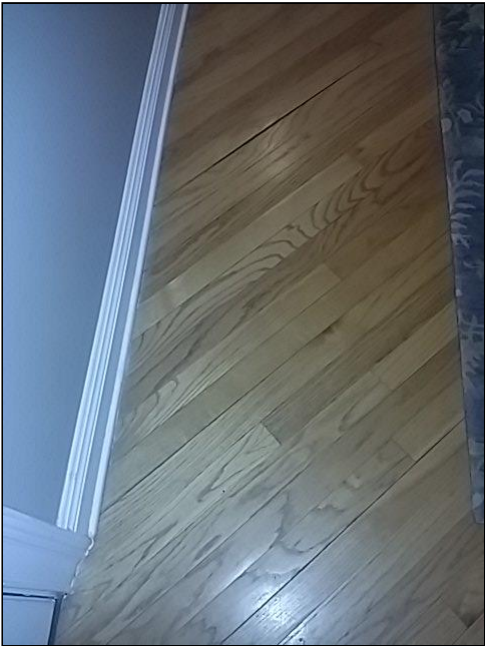
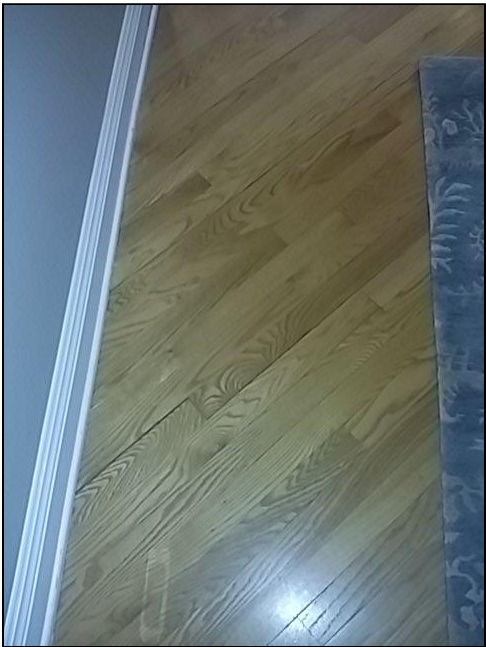
**4.2** Gaps were noted at the wood floors in the kitchen and living room. This is a cosmetic issue for your information. A qualified flooring contractor should repair as needed for proper appearance.

Gap in wood floor

Gaps at wood flooring

Gaps at wood floor

Gaps were noted at the wood floors in the kitchen and living room. This is a cosmetic issue for your information. A qualified flooring contractor should repair as needed for proper appearance.

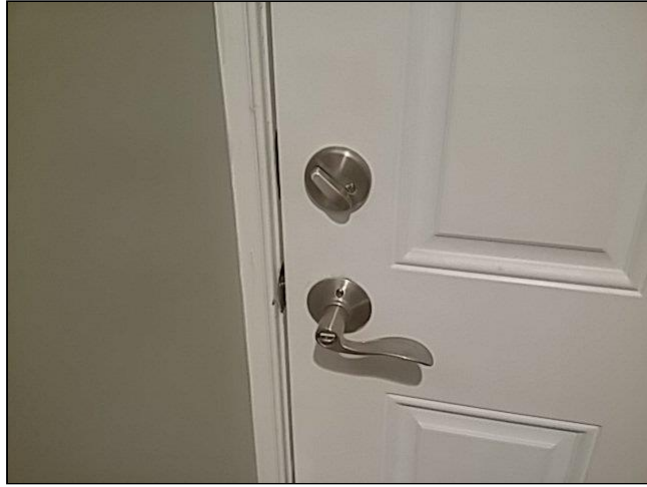
**4.3 (1)** The deadbolt will not engage at the rear entry door. This is a security issue. A qualified contractor or handyman should repair or replace as needed.

Deadbolt will not engage

(1) The deadbolt will not engage at the rear entry door. This is a security issue. A qualified contractor or handyman should repair or replace as needed.

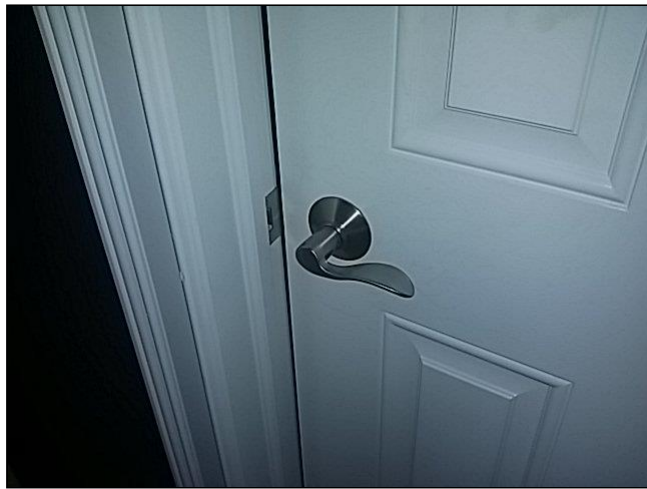
**4.3 (2)** The closet door needs a strike adjustment for the door knob to latch properly at the master bedroom. This is a deferred maintenance issue. A qualified contractor or handyman should repair or replace as needed.

Doorknob will not latch

(2) The closet door needs a strike adjustment for the door knob to latch properly at the master bedroom. This is a deferred maintenance issue. A qualified contractor or handyman should repair or replace as needed.

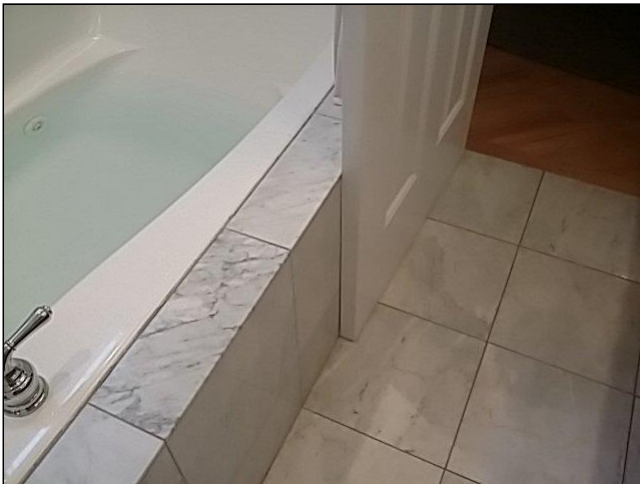
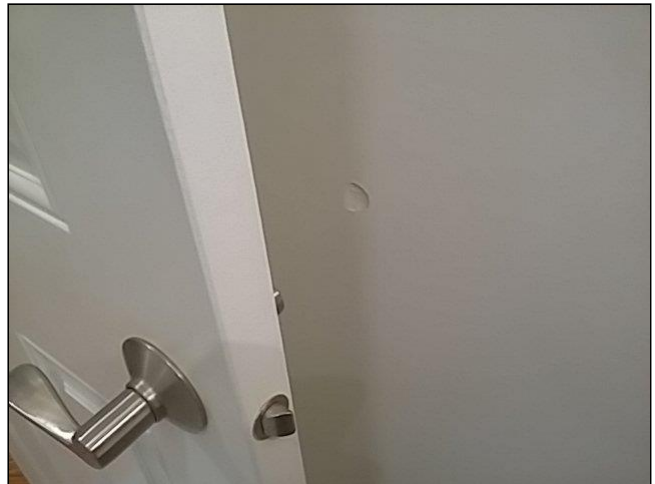
**4.3 (3)** Door stops (hinge mounted, floor mounted or wall mounted) should be in place on the interior doors in order to protect the adjacent finishes and door components from damage.

Master bath door strikes tub enclosure

Wall damage at hall bath

(3) Door stops (hinge mounted, floor mounted or wall mounted) should be in place on the interior doors in order to protect the adjacent finishes and door components from damage.

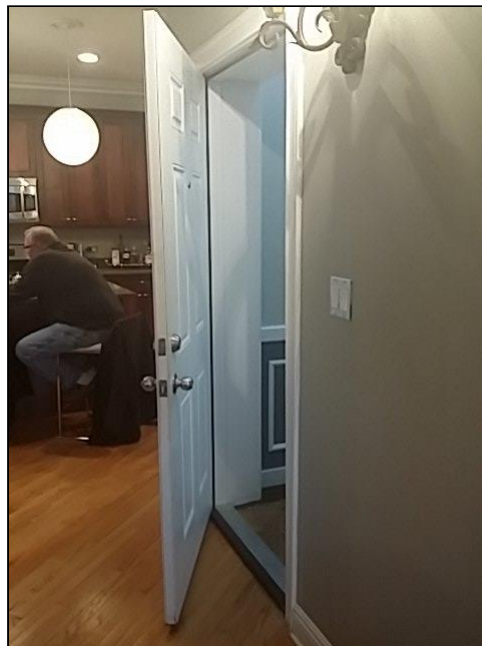
🔧 **4.3 (4)** The interior common area entry door to this unit and to all living units in the building should be made self-closing, as required by fire safety codes, in order to prevent fire spread within the structure and also to prevent the blocking of emergency egress during a fire. Spring hinges or a door closer should be installed so the door will close and latch automatically.

Unit entry door stays open

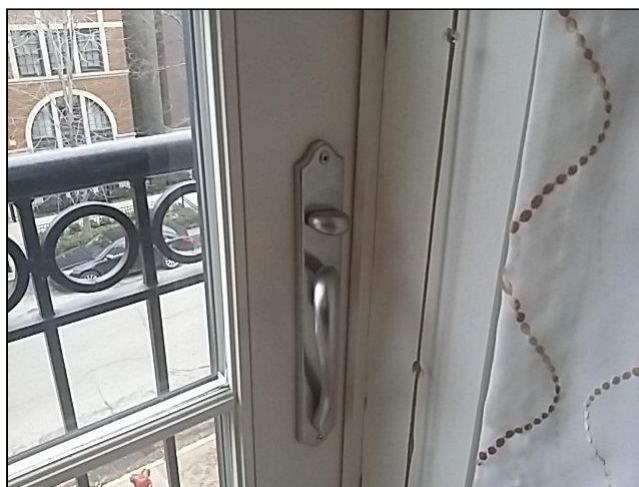
🔧 **4.3 (5)** The locking mechanism for the sliding door at the front of the home does not engage. This is a safety defect that needs to be corrected. A qualified contractor or handyman should repair or replace as needed for safety.

Door lock does not engage

(5) The locking mechanism for the sliding door at the front of the home does not engage. This is a safety defect that needs to be corrected. A qualified contractor or handyman should repair or replace as needed for safety.

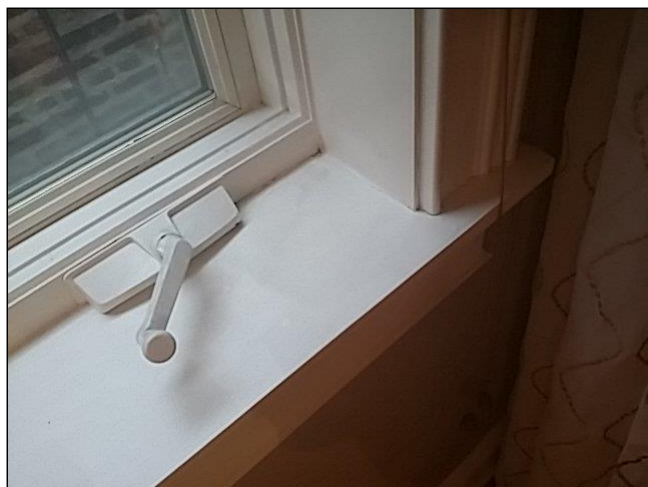
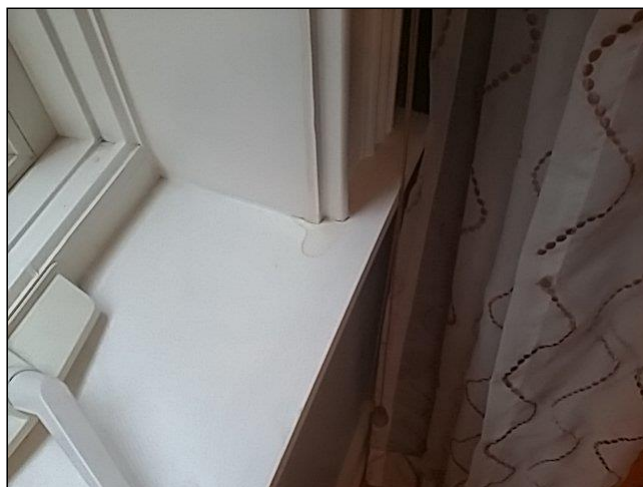
**4.4 (2)** Water damage was noted at the wood window sills in living room and dining room. This can indicate water leaks at the top of or around the windows. A qualified masonry contractor should evaluate further and repair as needed.

Water damage at dining room window sill

Water damage at living room window sill

(2) Water damage was noted at the wood window sills in living room and dining room. This can indicate water leaks at the top of or around the windows. A qualified masonry contractor should evaluate further and repair as needed.

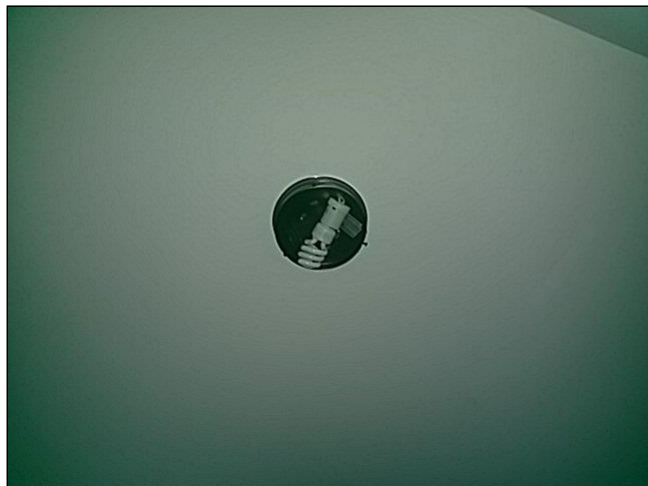
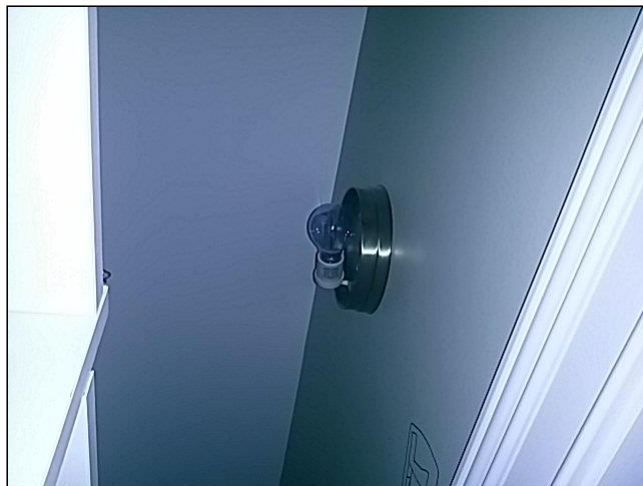
**4.6** The light fixtures are missing globes at the master bedroom and 2nd bedroom closet. This is a safety issue that needs to be corrected. A qualified licensed electrician should correct as needed.

Missing light globe

The light fixtures are missing globes at the master bedroom and 2nd bedroom closet. This is a safety issue that needs to be corrected. A qualified licensed electrician should correct as needed.

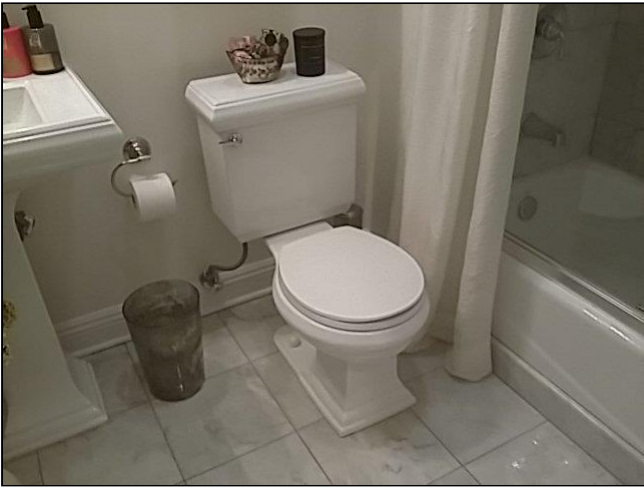
**5.3** The hall bath toilet is not adequately secured to the floor. This can result in deformation of the wax ring seal, leaking, and other damage. The toilet should be evaluated by a licensed and competent plumber in order to determine if removal and reinstallation is necessary.

Loose toilet

The hall bath toilet is not adequately secured to the floor. This can result in deformation of the wax ring seal, leaking, and other damage. The toilet should be evaluated by a licensed and competent plumber in order to determine if removal and reinstallation is necessary.

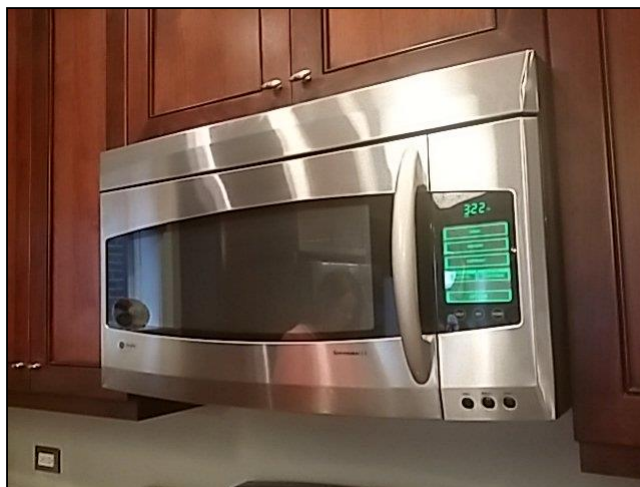
**6.8** The kitchen utilizes a combination microwave/recirculating vent hood. Cooking in the kitchen generates a great deal of odors and by-products that need to be ventilated to clean the air and to prevent damage to the home. The Client may opt to open windows or utilize a bathroom fan when cooking in order to enable some exterior venting during extended use of the kitchen range.

Recirculating kitchen exhaust

The kitchen utilizes a combination microwave/recirculating vent hood. Cooking in the kitchen generates a great deal of odors and by-products that need to be ventilated to clean the air and to prevent damage to the home. The Client may opt to open windows or utilize a bathroom fan when cooking in order to enable some exterior venting during extended use of the kitchen range.

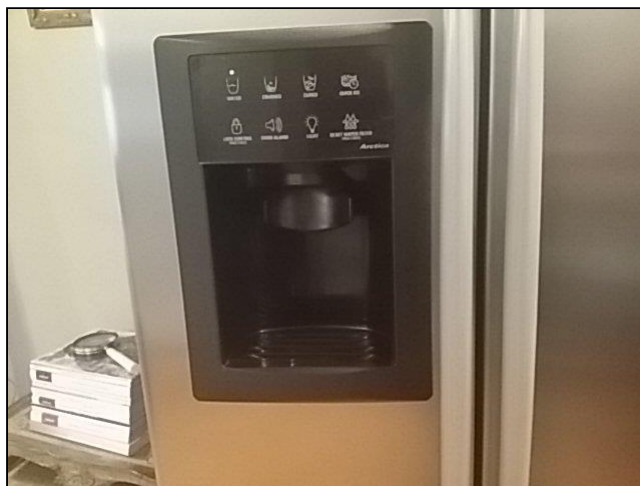
**6.9** The water dispenser at the front door of the refrigerator did not function when tested. A qualified appliance technician should evaluate further and repair as needed.

Water dispenser not working

The water dispenser at the front door of the refrigerator did not function when tested. A qualified appliance technician should evaluate further and repair as needed.

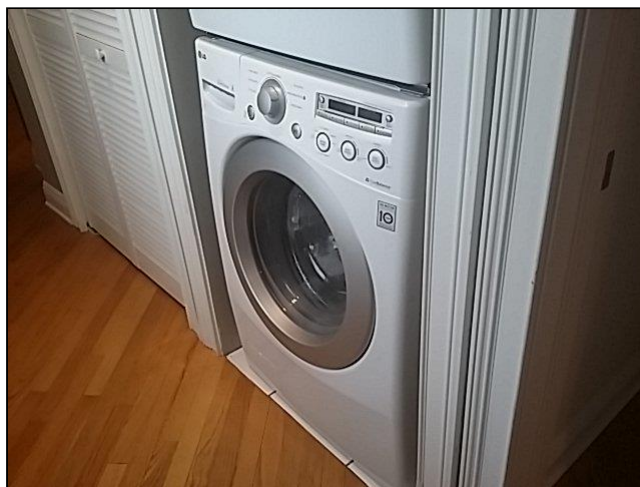
**6.12** Front load washer doors should be kept open when not in use to allow air flow that will promote drying and prevent mold growth at door seals.

Front load washer

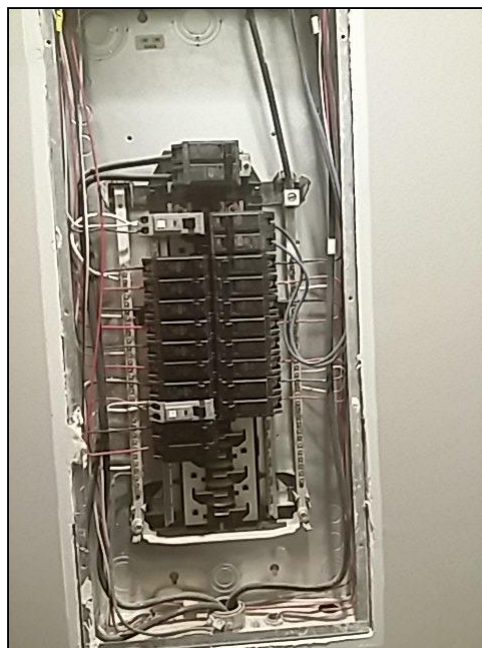
**7.1** The main electrical panel box/disconnect is located at the unit hallway.

Main electrical panel

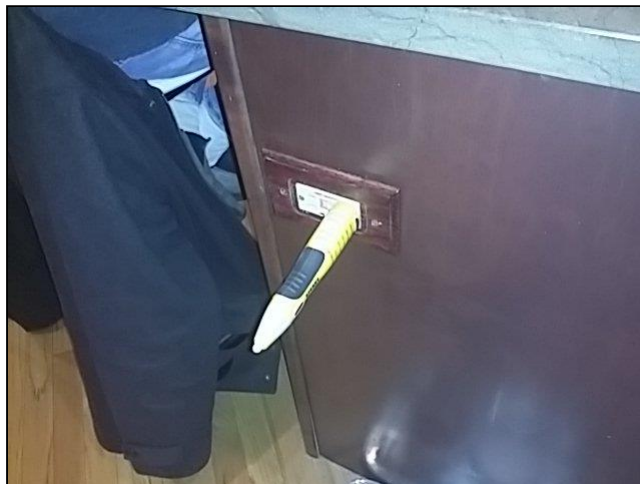
**7.4** The GFCI (Ground Fault Circuit Interrupter) outlet at the kitchen island is not grounded. This is a safety defect that can cause electric shock. A qualified licensed electrician should correct as needed.

Ungrounded outlet

The GFCI (Ground Fault Circuit Interrupter) outlet at the kitchen island is not grounded. This is a safety defect that can cause electric shock. A qualified licensed electrician should correct as needed.

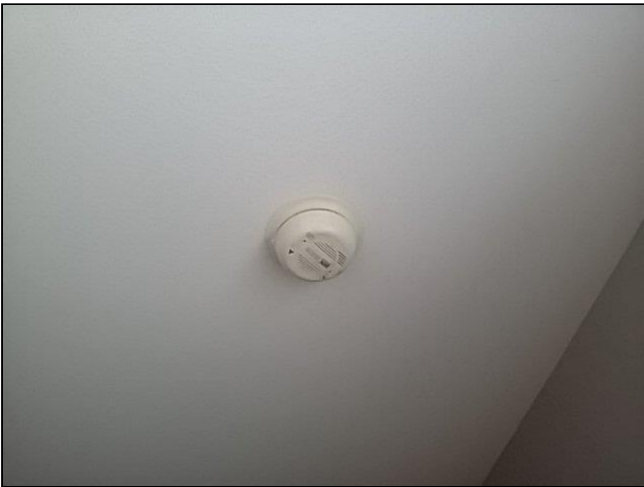
**7.5** Some of the safety detectors in the home appeared to be at or beyond the end of their service lives, typically taken to be 10 years for smoke detectors and 5 years for carbon monoxide detectors. It is recommended that the smoke detector and carbon monoxide detector systems be upgraded to reflect current life safety codes which include; smoke detectors on each level of living space and in each sleeping room, hard-wired 120 V smoke detectors that are interconnected in order to alarm simultaneously when any individual smoke detector responds, and carbon monoxide detectors on every level of living space and within 15 feet of a sleeping room. The installation of these critical life safety devices by a licensed and competent electrician is recommended.

Old, yellowed hallway smoke detector

Some of the safety detectors in the home appeared to be at or beyond the end of their service lives, typically taken to be 10 years for smoke detectors and 5 years for carbon monoxide detectors. It is recommended that the smoke detector and carbon monoxide detector systems be upgraded to reflect current life safety codes which include; smoke detectors on each level of living space and in each sleeping room, hard-wired 120 V smoke detectors that are interconnected in order to alarm simultaneously when any individual smoke detector responds, and carbon monoxide detectors on every level of living space and within 15 feet of a sleeping room. The installation of these critical life safety devices by a licensed and competent electrician is recommended.

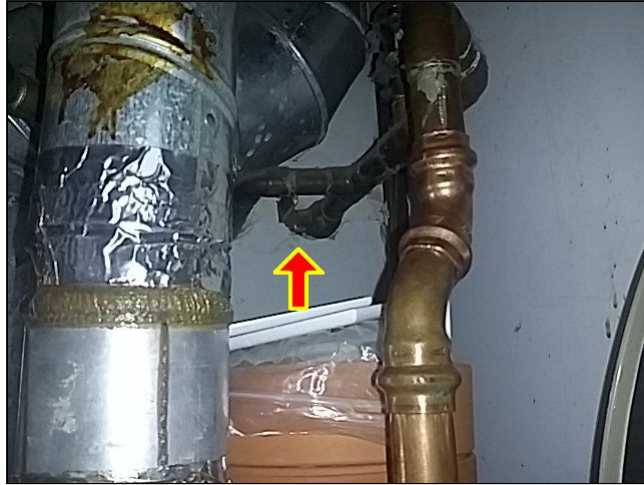
**8.1** The main water supply shut off is the yellow lever located above the water heater.

Main water shut-off

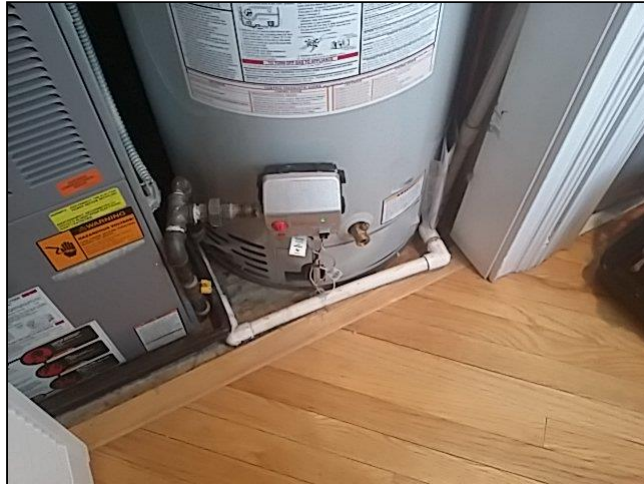
**8.3** A drain pan is required to be placed underneath the water heater when one is installed above living space. A drain pan should be installed and connected to the nearby floor drain in order to reduce the risk of leaking and damage. A qualified plumbing contractor should install as needed.

No drain pan at water heater

A drain pan is required to be placed underneath the water heater when one is installed above living space. A drain pan should be installed and connected to the nearby floor drain in order to reduce the risk of leaking and damage. A qualified plumbing contractor should install as needed.

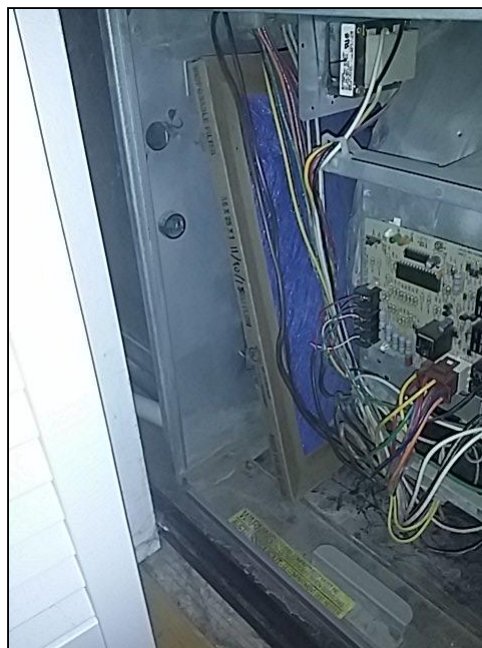
**9.1 (1)** The furnace filter is not properly fitted and secured inside the housing and has been bypassing dirty air. It is likely there is dirt build-up on the interior components of the evaporator coil which can't be seen. This can reduce the efficiency of the system and can also reduce indoor air comfort. The entire HVAC unit; including the blower assembly, heat exchanger, and evaporator coil should be professionally cleaned for optimal system performance. The filter housing should be modified to ensure an airtight seal at the filter.

Filter not properly sealed in furnace

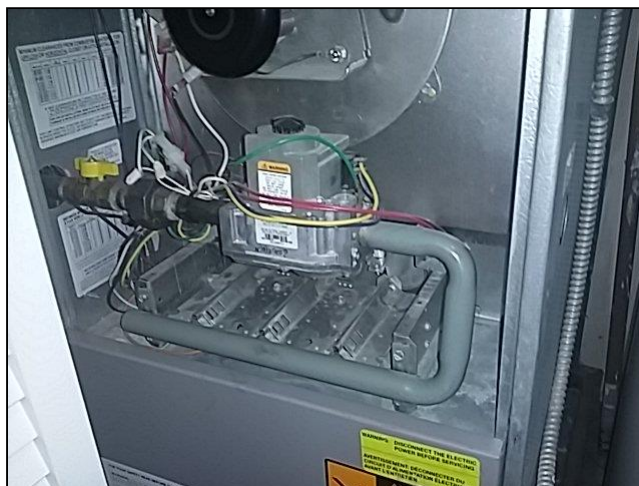
**9.1 (2)** The furnace is short-cycling (burner operates for several seconds then shuts off. This can be caused by a defective gas valve or can be the result of a faulty sensor. A qualified HVAC contractor should evaluate further and repair or replace as needed.

Furnace short cycling in heating mode

(2) The furnace is short-cycling (burner operates for several seconds then shuts off. This can be caused by a defective gas valve or can be the result of a faulty sensor. A qualified HVAC contractor should evaluate further and repair or replace as needed.

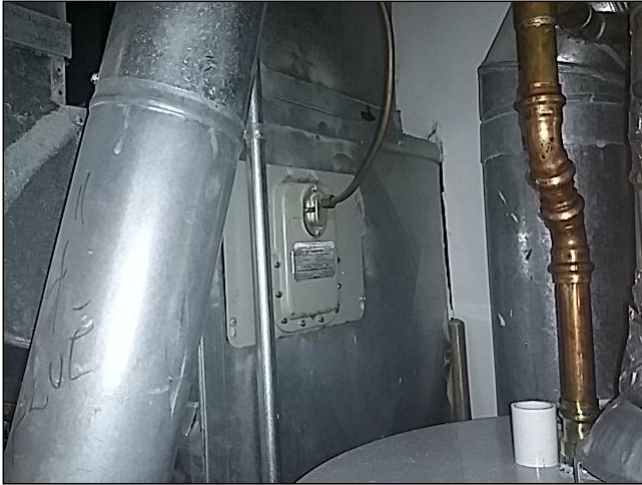
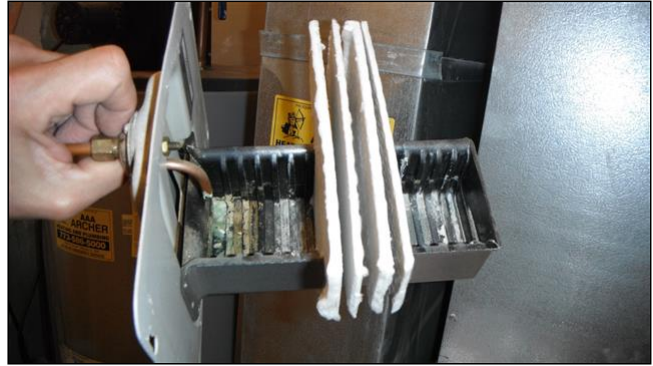
**9.2** The existing furnace-mounted humidifier relies on standing water for humidification of the conditioned air. This unit is difficult to clean and can allow molds, bacteria, and other biologicals to grow inside the conditioned air stream. It should be replaced with a more indoor air quality friendly unit by a licensed HVAC contractor.

Standing water humidifier

Typical humidifier interior

The existing furnace-mounted humidifier relies on standing water for humidification of the conditioned air. This unit is difficult to clean and can allow molds, bacteria, and other biologicals to grow inside the conditioned air stream. It should be replaced with a more indoor air quality friendly unit by a licensed HVAC contractor.

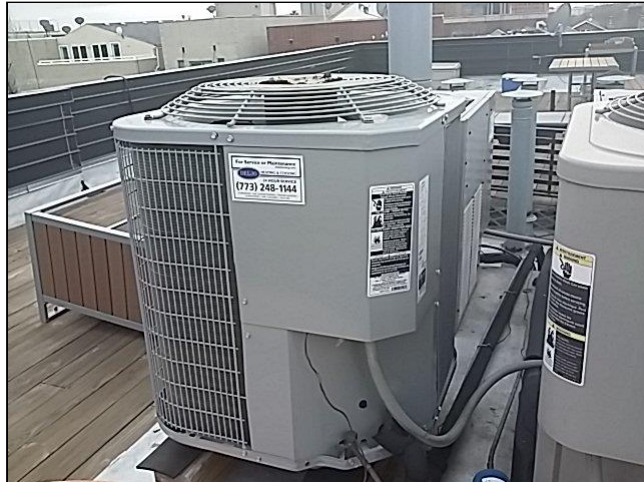
**9.5** Since the ambient temperature did not allow for the safe operation of the air-conditioning system, a home warranty or an escrow hold-back should be considered in order to protect the purchaser in the event that the air-conditioning system is defective or inoperative. Further evaluation of the air-conditioning system by a licensed and competent HVAC contractor is recommended when weather permits.

AC condenser

Since the ambient temperature did not allow for the safe operation of the air-conditioning system, a home warranty or an escrow hold-back should be considered in order to protect the purchaser in the event that the air-conditioning system is defective or inoperative. Further evaluation of the air-conditioning system by a licensed and competent HVAC contractor is recommended when weather permits.
