Inspection Report

Property Address:

1233 Main St

DLM Home Inspection

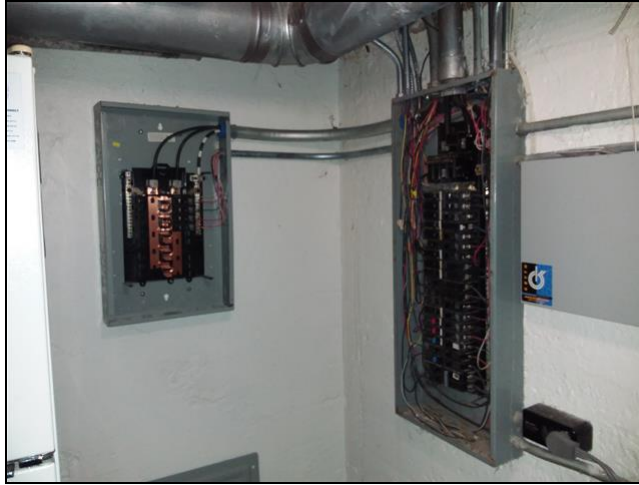
**5.1 (5)** The main electrical panel box/disconnect is located at the basement.

Main electrical panel and sub-panel with covers removed

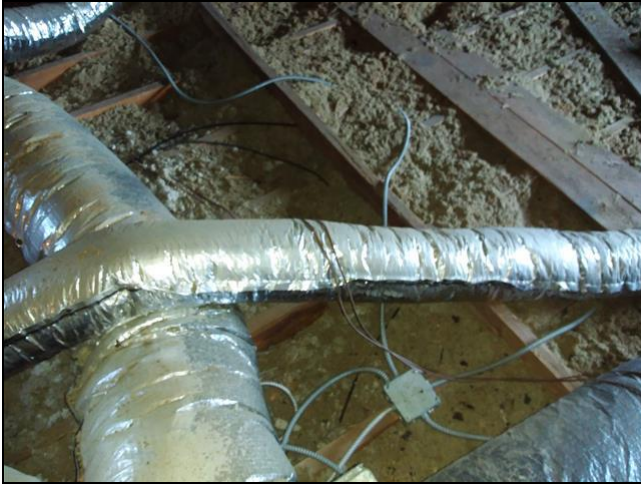
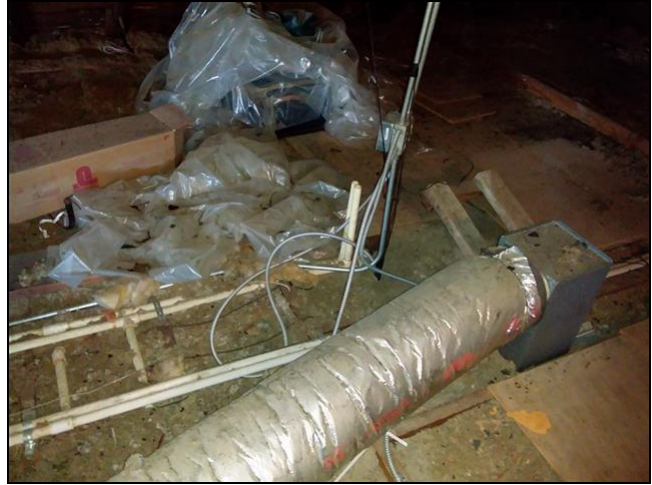
**5.2 (2)** The electrical wiring in the attic and crawlspace is not secured to wood members properly and was not installed neatly or in 90 degree turns as in standard workmanlike practice. This poor quality work may indicate the installation was performed by unlicensed and/or unqualified personnel. The wiring should be reviewed by a qualified electrical contractor for safety.

Amateur attic wiring

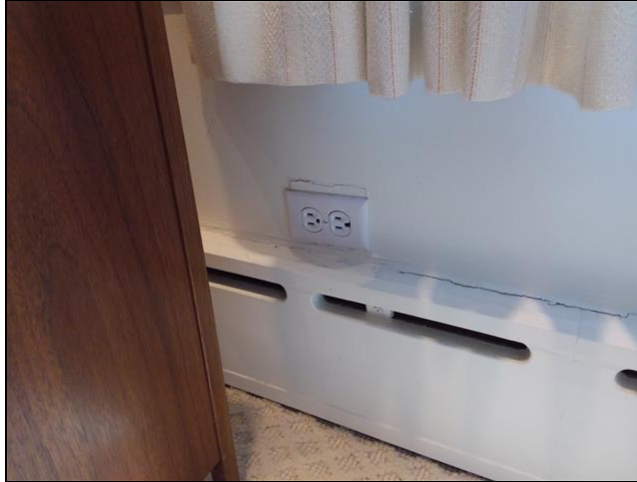
**5.3 (1)** Electrical outlets should not be located directly over baseboard radiant heater elements. A qualified electrical contractor should relocate the outlets to prevent melting or damaged power cords that can result in fire or electric shock.

Outlet installed over radiator

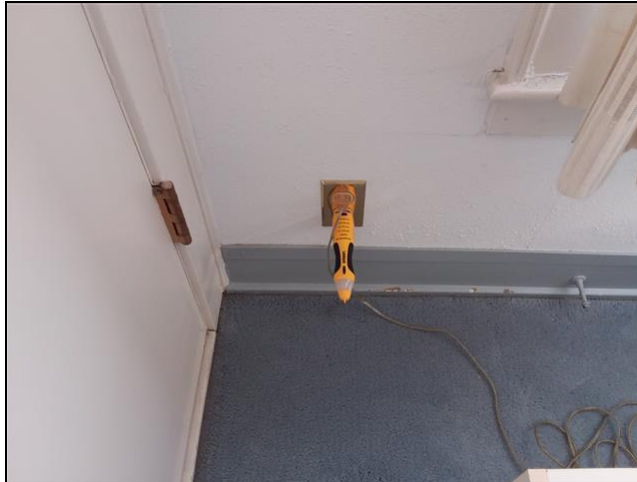
**5.3 (2)** One outlet is not grounded in the South bedroom. This is a safety defect that can cause electric shock. A qualified licensed electrician should repair as needed.

Ungrounded outlet

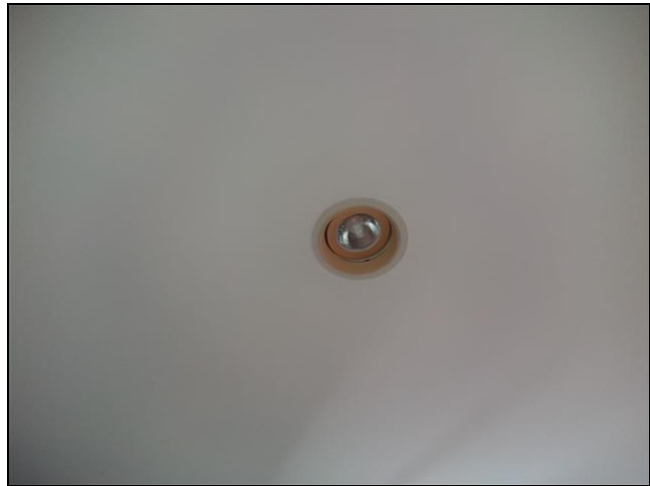
Family room ceiling light out

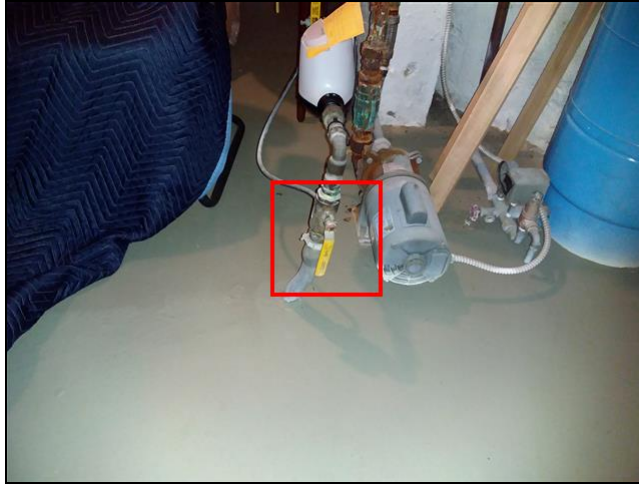
**6.0** The main water supply shut off is the yellow lever located in the basement.

Main water shut-off

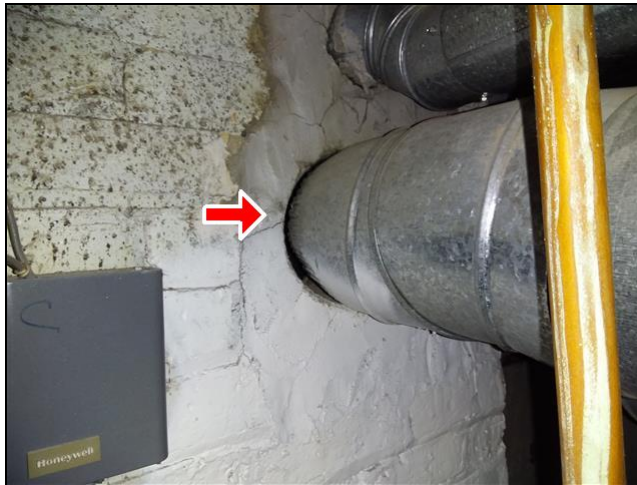
**7.5** The vent pipes for the boiler, gas furnace and water heater need mastic sealed around the pipes where they enter the chimney. The vent piping connection to the chimney should be evaluated by a qualified contractor in order to insure safe and effective venting of dangerous flue gases.

Large gaps at chimney connection

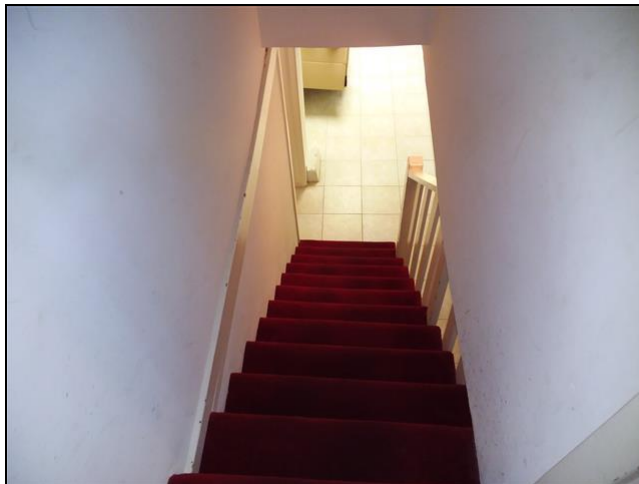
**11.5 (1)** Secure and graspable handrails are required at all interior stairs in order to provide for safe stair travel. A qualified contractor should install as needed.

Add full railing at basement stairs
